**BUILDING-STRUCTURE INVENTORY FORM**

- 1. BUILDING NAME(S): Building 46-Viele Building
- 2. COUNTY: Suffolk TOWN/CITY: Islip VILLAGE: Central Islip
- 3. STREET LOCATION: east side of Carleton Ave.
- 4. OWNERSHIP: a. public  b. private
- 5. PRESENT OWNER: New York State ADDRESS: \_\_\_\_\_
- 6. USE: Original: \_\_\_\_\_ Present: vacant
- 7. ACCESSIBILITY TO PUBLIC: Exterior visible from public road: Yes  No   
Interior accessible: Explain \_\_\_\_\_

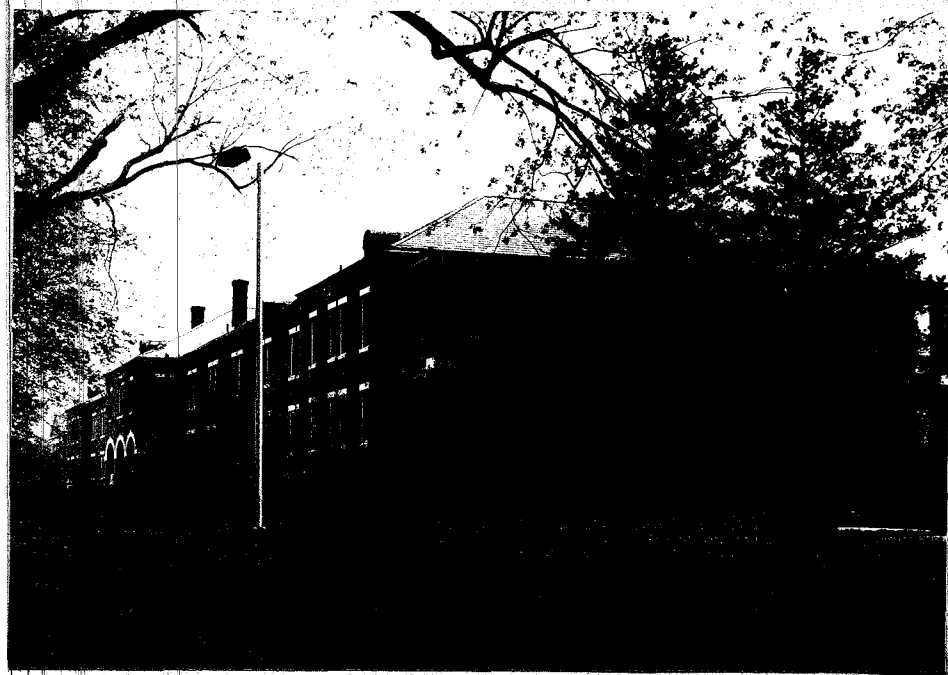
12. PHOTO: CI-WHC-r-1,30 from SW

vacant & vandalized . TOP FLOOR BURNED IN EARLY 1930'S . NEW ROOF ELIMINATED THAT FLOOR.
