BUILDING-STRUCTURE INVENTORY FORM

IDENTIFICATION ~~TAYLOR ESTATE RESIDENCE~~ LT-26

- 1. BUILDING NAME(S) (Superintendents Residence, Heckscher State Park) 032
- 2. COUNTY: Suffolk TOWN/CITY: Islip VILLAGE: East Islip
- 3. STREET LOCATION: Timber Point Rd; South side
- 4. OWNERSHIP: a. public b. private
- 5. PRESENT OWNER: LISPC ADDRESS: Belmont State Park
- 6. USE: Original: Residence Present: Same
- 7. ACCESSIBILITY TO PUBLIC: Exterior visible from public road: Yes No
Interior accessible: Explain

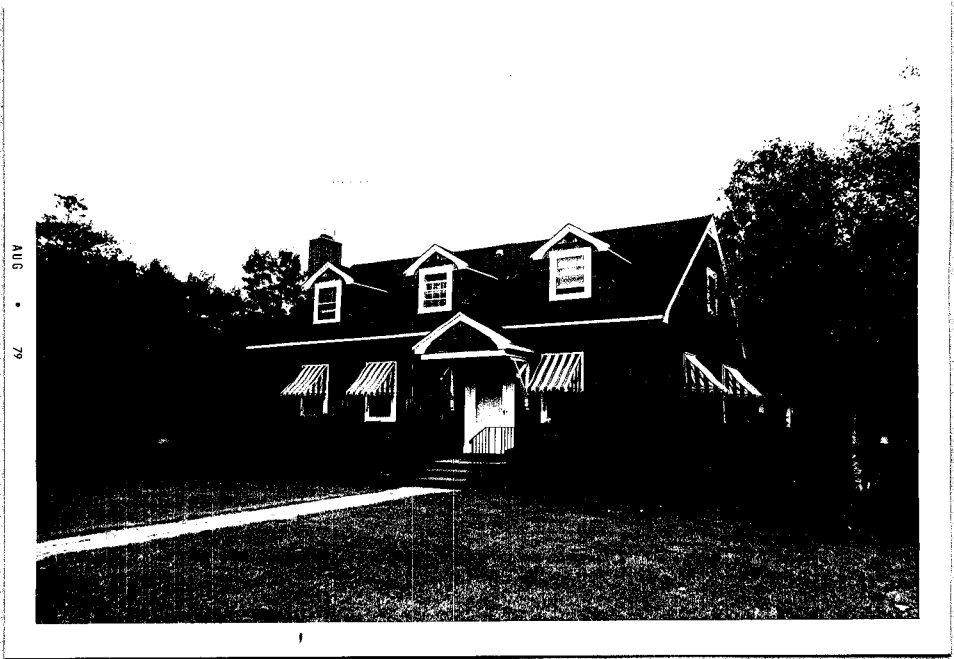
Roll 2 Bay Shore East Quadrangle
12. PHOTO: H 3 - 14 South East Corner 13. MAP:
South facade

18. OTHER NOTABLE FEATURES OF BUILDING AND SITE (including interior features if known):
 4 bay 1 1/2 story shingled house with 3 gable dormers in gable roof.
 Doorway is framed with colonial trim of mid 20th C,
 Bracketed hood over entrance.

20. HISTORICAL AND ARCHITECTURAL IMPORTANCE:
 One of the buildings of the Taylor-Pyne estate. > ?
 * The brackets holding the porch roof are the only visible details of its origin.

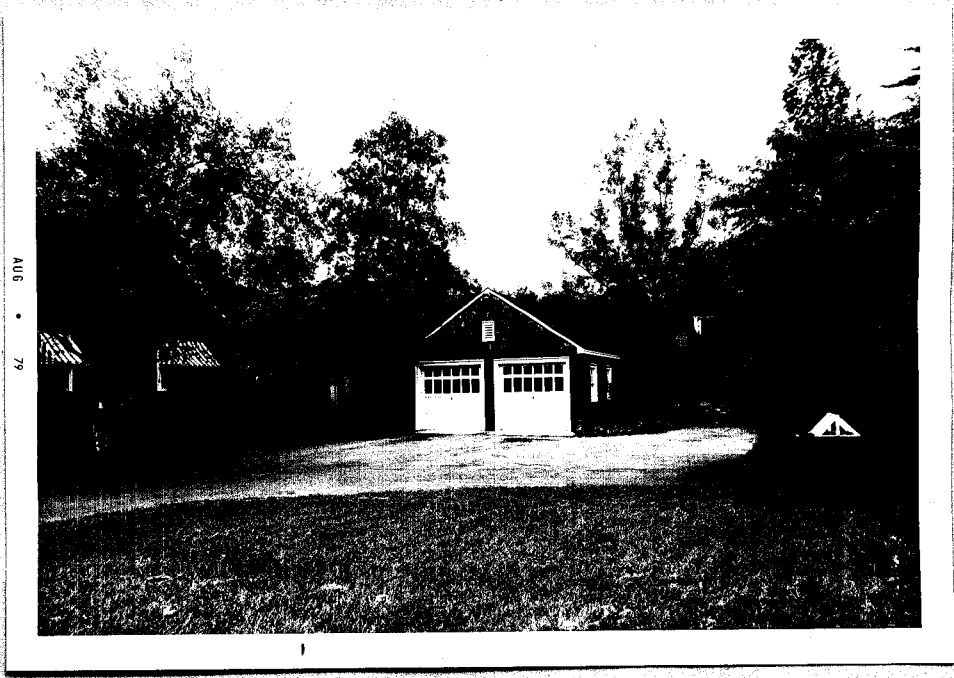
Roll 2
12. PHOTO: H 4 - 15
South East

18. OTHER NOTABLE FEATURES OF BUILDING AND SITE (including interior features if known):
 2 car gable roof shingled one story garage

20. HISTORICAL AND ARCHITECTURAL IMPORTANCE:
 Typical two car garage
