BUILDING-STRUCTURE INVENTORY FORM

1. BUILDING NAME(S): 68 Montgomery Avenue - Dawson House
 2. COUNTY: Suffolk TOWN/CITY: Islip VILLAGE: Bay Shore
 3. STREET LOCATION: 68 Montgomery Avenue
 4. OWNERSHIP: a. public b. private
 5. PRESENT OWNER: _____ ADDRESS: _____
 6. USE: Original: residence Present: residence
 7. ACCESSIBILITY TO PUBLIC: Exterior visible from public road: Yes No
 Interior accessible: Explain private residence

- 1. BUILDING NAME(S): House at #68 South Montgomery Avenue
- 2. COUNTY: Suffolk TOWN/CITY: Islip VILLAGE: Bay Shore
- 3. STREET LOCATION: #68 So. Montgomery Ave. (west side, bet. First Ct. & Montgomery Lane)
- 4. OWNERSHIP: a. public b. private
- 5. PRESENT OWNER: _____ ADDRESS: _____
- 6. USE: Original: Residence Present: Residence
- 7. ACCESSIBILITY TO PUBLIC: Exterior visible from public road: Yes No
Interior accessible: Explain By appointment only

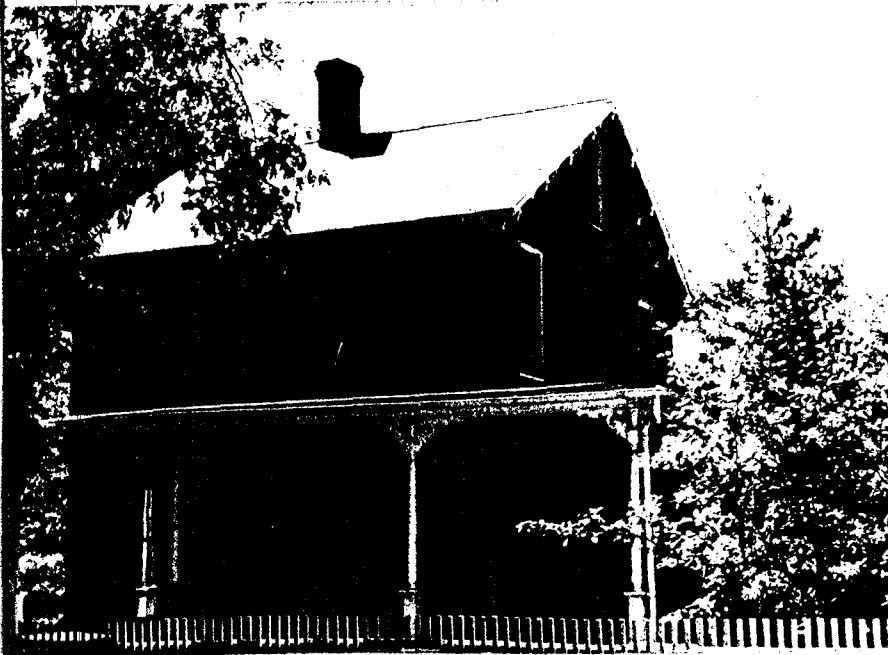
Bay Shore Roll #Q6; Neg. #20
Front & North Sides

18. OTHER NOTABLE FEATURES OF BUILDING AND SITE (including interior features if known):
 This two and one-half story house is three bays long and has a gable roof. It is two bays wide on the sides. There is a projecting one story wing on the north side. There is a rear wing as well, and a rear porch at the southwest corner.
