BUILDING-STRUCTURE INVENTORY FORM

* * * * * * * *	* * * * * * * * * * * * * * * * * * *	* * * * * * *	* * * * * * *
IDENTIFICATION	Vanderbilt Chicker		
1. BUILDING NAM		나는 바로 가지 않는데 얼마를 하는데 없다.	한 발생이 되지나 말했다. 그는 생기가 하였다.

2. COUNTY:	Suffolk TOWN/CITY:	TRTTD AILI	AGE: Oakdare
3. STREET LOCAT	ION: 4 Jade Street		
4. OWNERSHIP:	a. public 🔲 b private 🗷		# *
5. PRESENT OWNE	R: Bunting A Chicken coop Pr	DDRESS: See	72

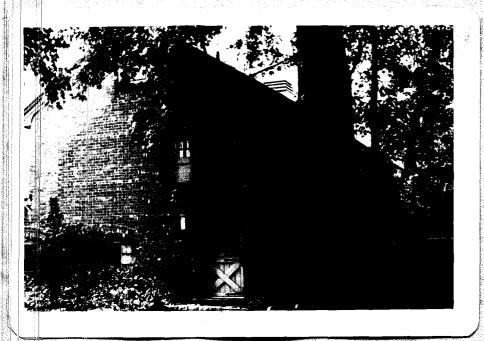
12. PHOTO: Neg. 18, east facade NJM-1

18.	OTHER NOTABLE FEATURES OF BUILDING AND SITE (including interior features if known):
	2 story brick structure with gable roof. Vent survives on roof of 1 story portion.
<u>SIC</u> 19.	NIFICANCE DATE OF INITIAL CONSTRUCTION: 1890
	ARCHITECT:
	BUILDER: William Bason and Sons
