**BUILDING-STRUCTURE INVENTORY FORM**

- 1. BUILDING NAME(S): Frank Swanda House
- 2. COUNTY: Suffolk TOWN/CITY: Islip VILLAGE: Bohemia
- 3. STREET LOCATION: 811 Locust Ave.
- 4. OWNERSHIP: a. public  b. private
- 5. PRESENT OWNER: \_\_\_\_\_ ADDRESS: \_\_\_\_\_
- 6. USE: Original: residence Present: residence
- 7. ACCESSIBILITY TO PUBLIC: Exterior visible from public road: Yes  No   
Interior accessible: Explain private residence

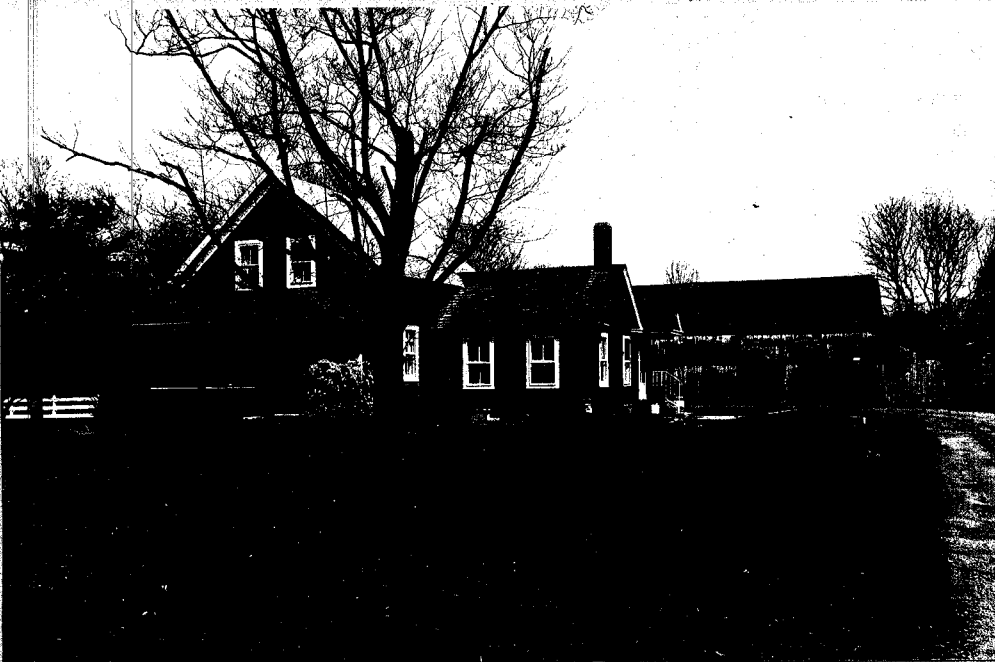
12. PHOTO: Neg. KK XXI-16, fm. W/SW 13. MAP: NYS DOT Patchogue Quad

18. OTHER NOTABLE FEATURES OF BUILDING AND SITE (including interior features if known):  
 811 Locust Avenue is a 1½ story, three bay, side entrance plan, gable roof house set perpendicular to the street with a smaller, two bay, gable roof south wing with an interior end chimney. 2/2 windows remain throughout the house. The house retains an open front porch with shingled posts. The large, vertical board, gable roof barn retains sliding batten doors and characteristic shed roof south extension with six pane window.

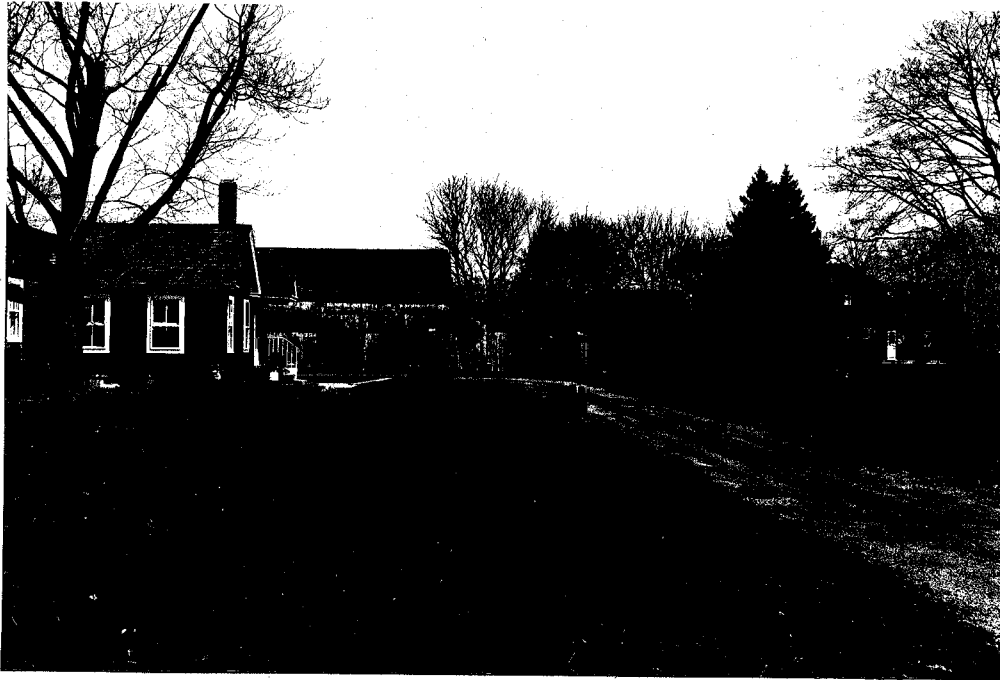
Neg. KK XXI-17, fm. W/SW, showing portion of barn, the prive, and corn crib.
