BUILDING-STRUCTURE INVENTORY FORM

UNIQUE SITE NO. 163-05-0592-HSP
QUAD _____
SERIES _____
NEG. NO. _____

TAYLOR ESTATE: STABLES

1. BUILDING NAME(S): (Sign Shop Heckscher State Park.)

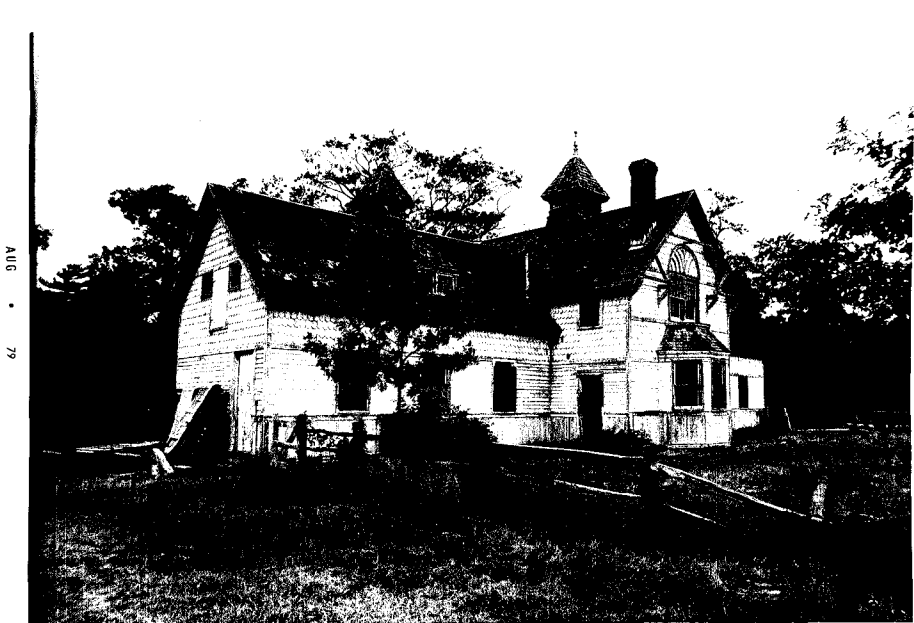
12. PHOTO: H 12 - 17
South East Corner

A 2½ story gable roof wood sided building with cross gable center element, surmounted by louvered ventilators with turned finial. S.E. side has paired windows with carved half timbering applied over vertical boarding over 3 bay baywindow with stick style brackets and braces. Siding is 3 layers, vertical boards, shingles and scalloped shingles.

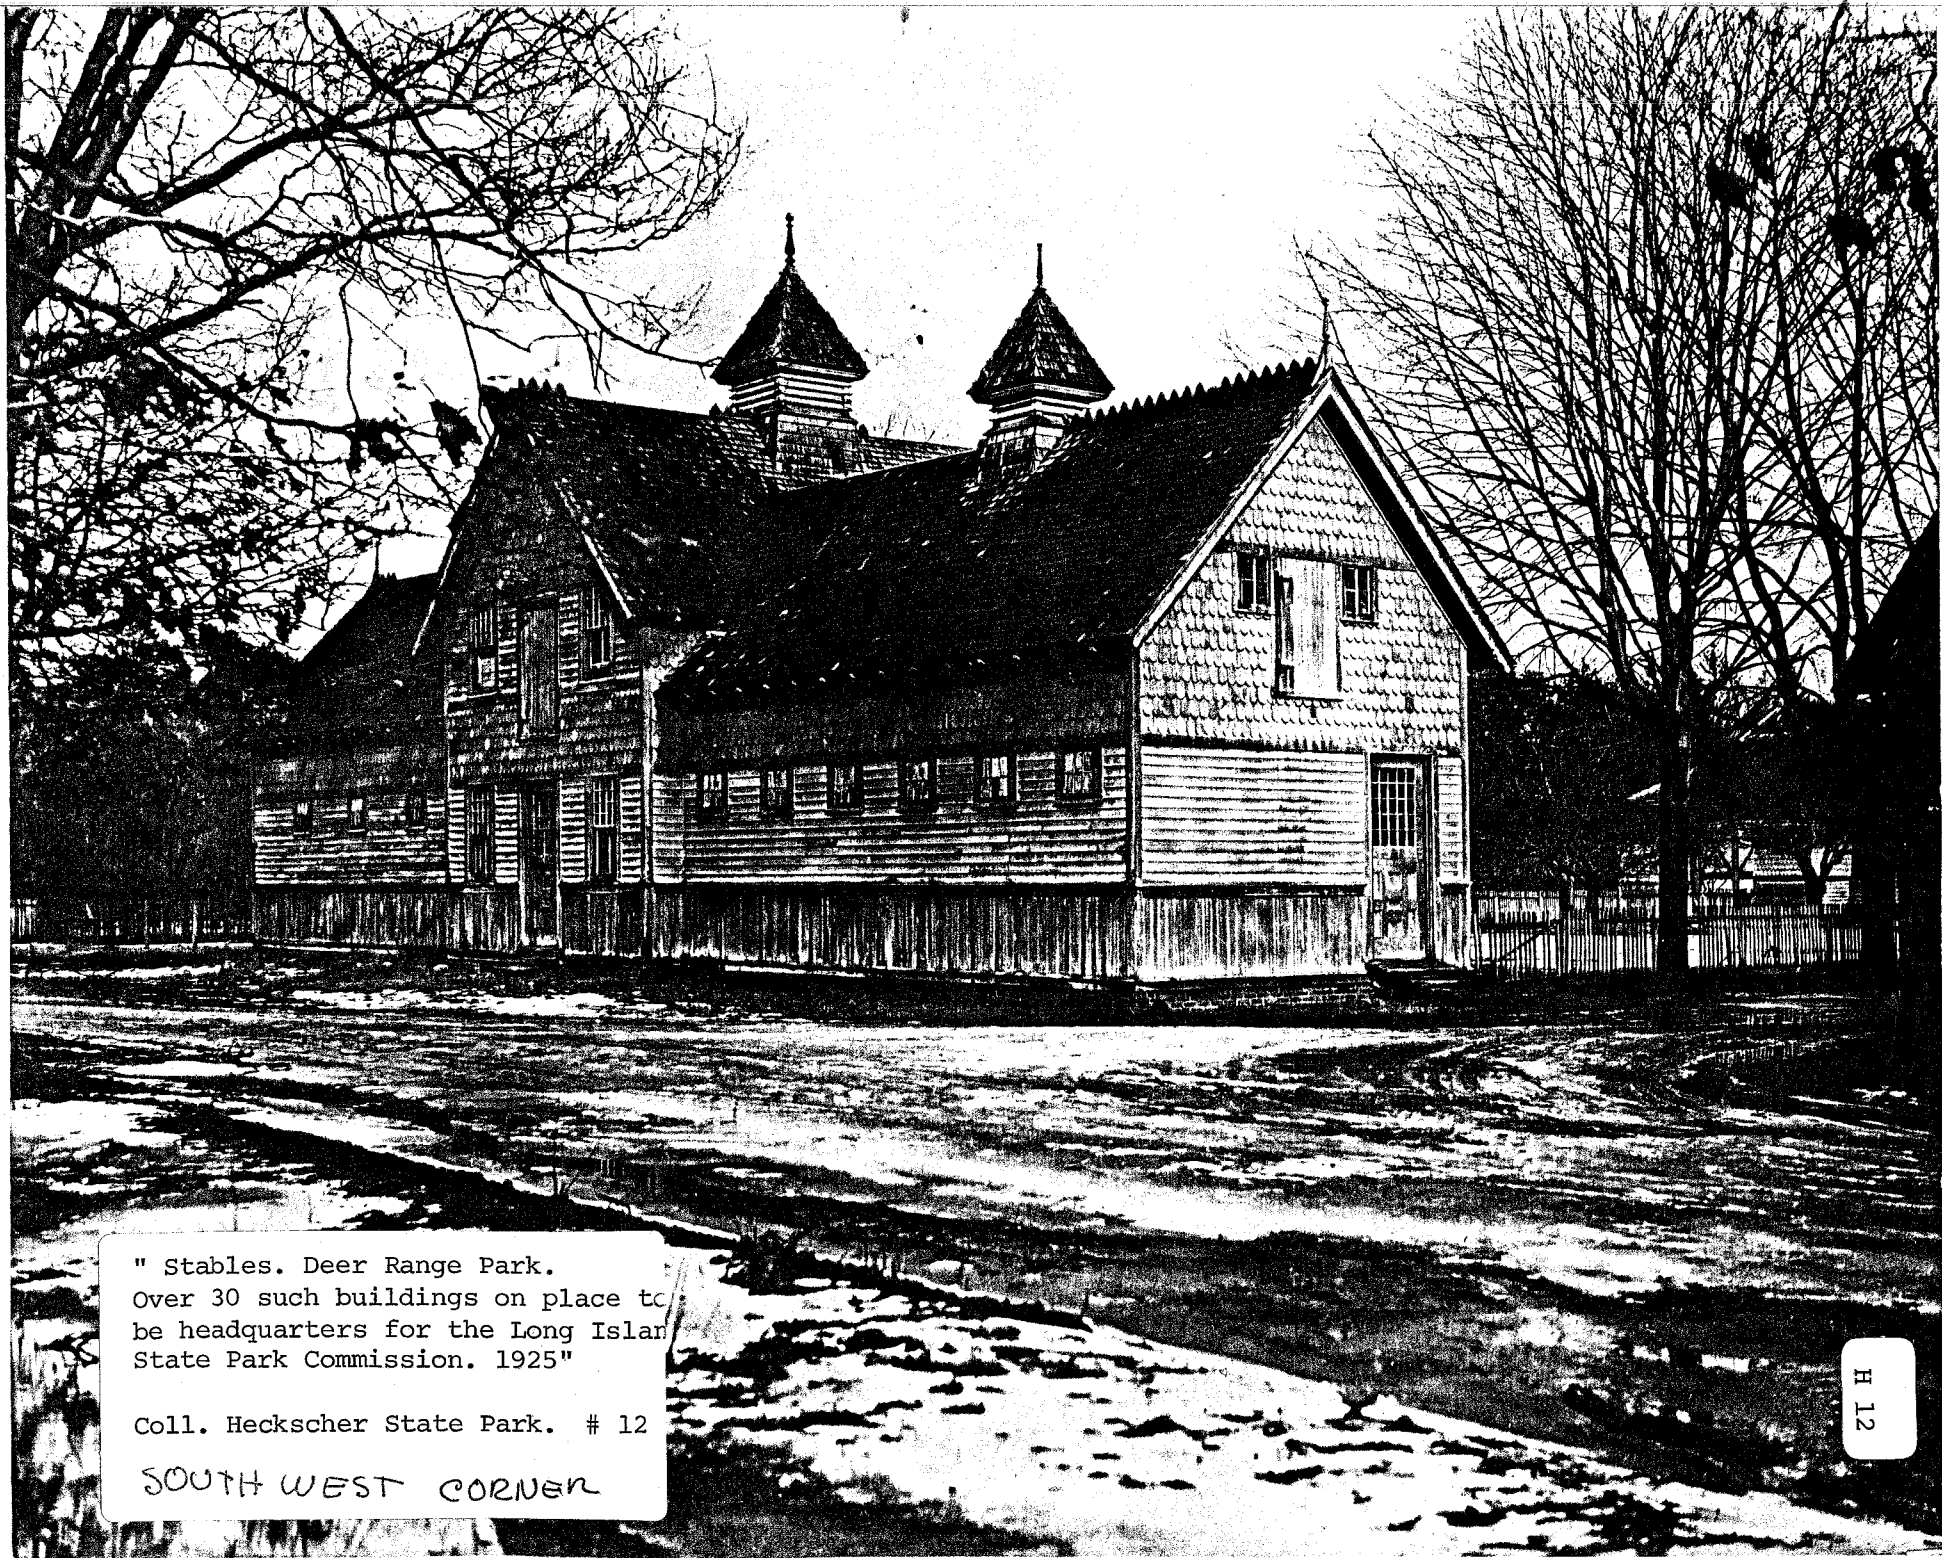
SOUTH WEST CORNER

" Stables. Deer Range Park.
Over 30 such buildings on place to
be headquarters for the Long Island
State Park Commission. 1925"
