BUILDING-STRUCTURE INVENTORY FORM

* * * * * * * * * *	
<u>DENTIFICATION</u>	
. BUILDING NAME(S):	McKenna House (?)
2. COUNTY: <u>Suffolk</u>	t TOWN/CITY: <u>Islip</u> VILLAGE: <u>Bay Shore</u>

3. STREET LOCATION:	121 Fifth Avenue
I. OWNERSHIP: a. publi	121 Fifth Avenue ic 口 b. private 図
5. PRESENT OWNER:	ADDRESS:sidencePresent:residence
o, USE: Original: <u>res</u>	<u>sidence</u> Present: <u>residence</u>

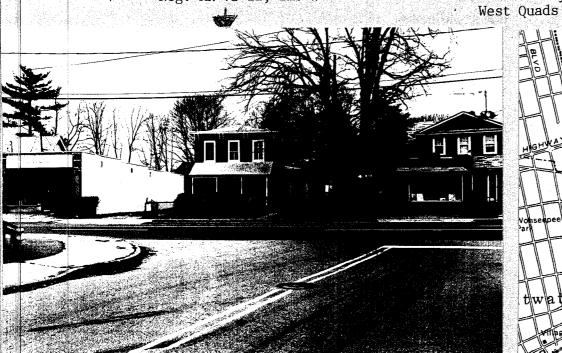
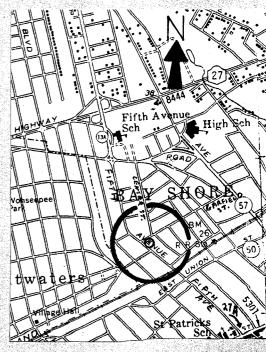
l. INTEGRITY: a. origin	nal site 🗗 b. moved 🔲 if so,when?
	najor alterations and dates (if known):
porc	ch replaced
2. PHOTO: Neg KK V	71-12, fm. W 13. MAP : NYS DOT Bay Shore Eas

17.	INTERRELATIONSHIP OF BUILDING AND SURROUNDINGS: (Indicate if building or structure is in an historic district)
• 6	121 Fifth Avenue is located in a mixed commercial and residential area, one of few recognizably historic buildings in the immediate area. The property retains integrity among commercial interests that surround the treed parcel.
IO.	OTHER NOTABLE FEATURES OF BUILDING AND SITE (including interior features if known): 121 Fifth Avenue is a two story, low hip roof Italianate house with paired brackets under the eaves. The three bay, side entrance plan principle facade contains an unusual double leaf door with a double tier of glazed panels in a segmental arch. The house features 4/4 windows.
SIG	NIFICANCE -
