BUILDING-STRUCTURE INVENTORY FORM

III-4
D01

- 1. BUILDING NAME(S): (Ski Shop)
- 2. COUNTY: Suffolk TOWN/CITY: Islip VILLAGE: Bay Shore
- 3. STREET LOCATION: 112 - 106 Main St. (South side, bet. Ocean and Park)
- 4. OWNERSHIP: a. public b. private
- 5. PRESENT OWNER: _____ ADDRESS: _____
- 6. USE: Original: _____ Present: _____
- 7. ACCESSIBILITY TO PUBLIC: Exterior visible from public road: Yes No
Interior accessible: Explain during store hours

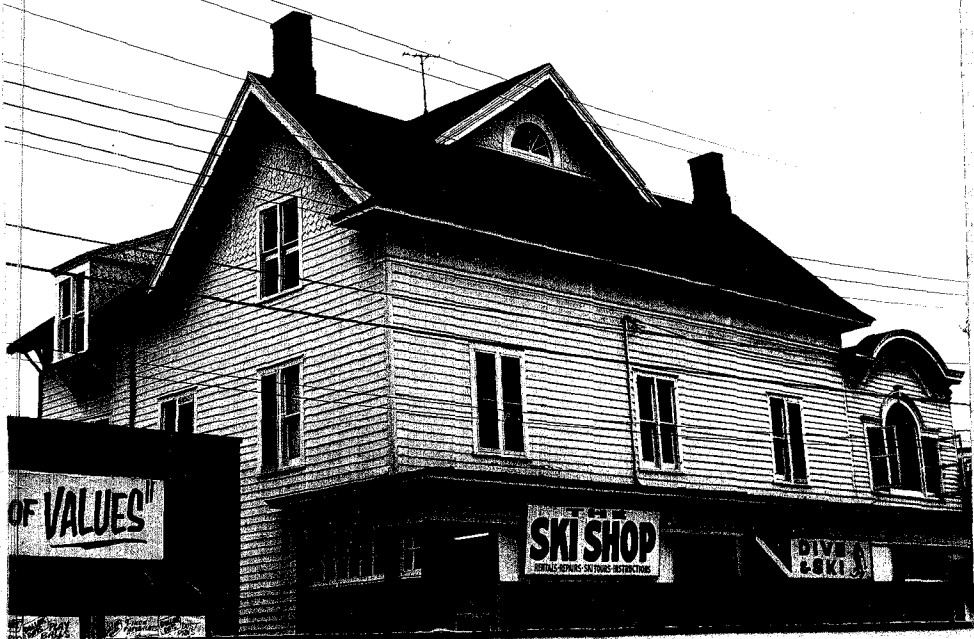
HP-1 Bay Shore Roll #Q3; Neg. #4

This cluster of three stores is housed in a Victorian structure with a variety of architectural features. The front gable has variegated shingles with a semi-circular window with molded architrave. Number 112, apparently built at a different time than the main structure, has a Palladian window with the roof line following SIGNIFICANCE the line of the window.

Architecturally, the building yields a variety of Victorian elements and ornaments. There is a mixture of decorative shingle and clapboard; projecting eaves with decorative brackets, a gabled dormer with triangular brackets, a vergeboard on the south facade. Despite remodelling, particularly at the first floor level, the building maintains its Victorian qualities of massing and texture, as well as much of its original ornament.

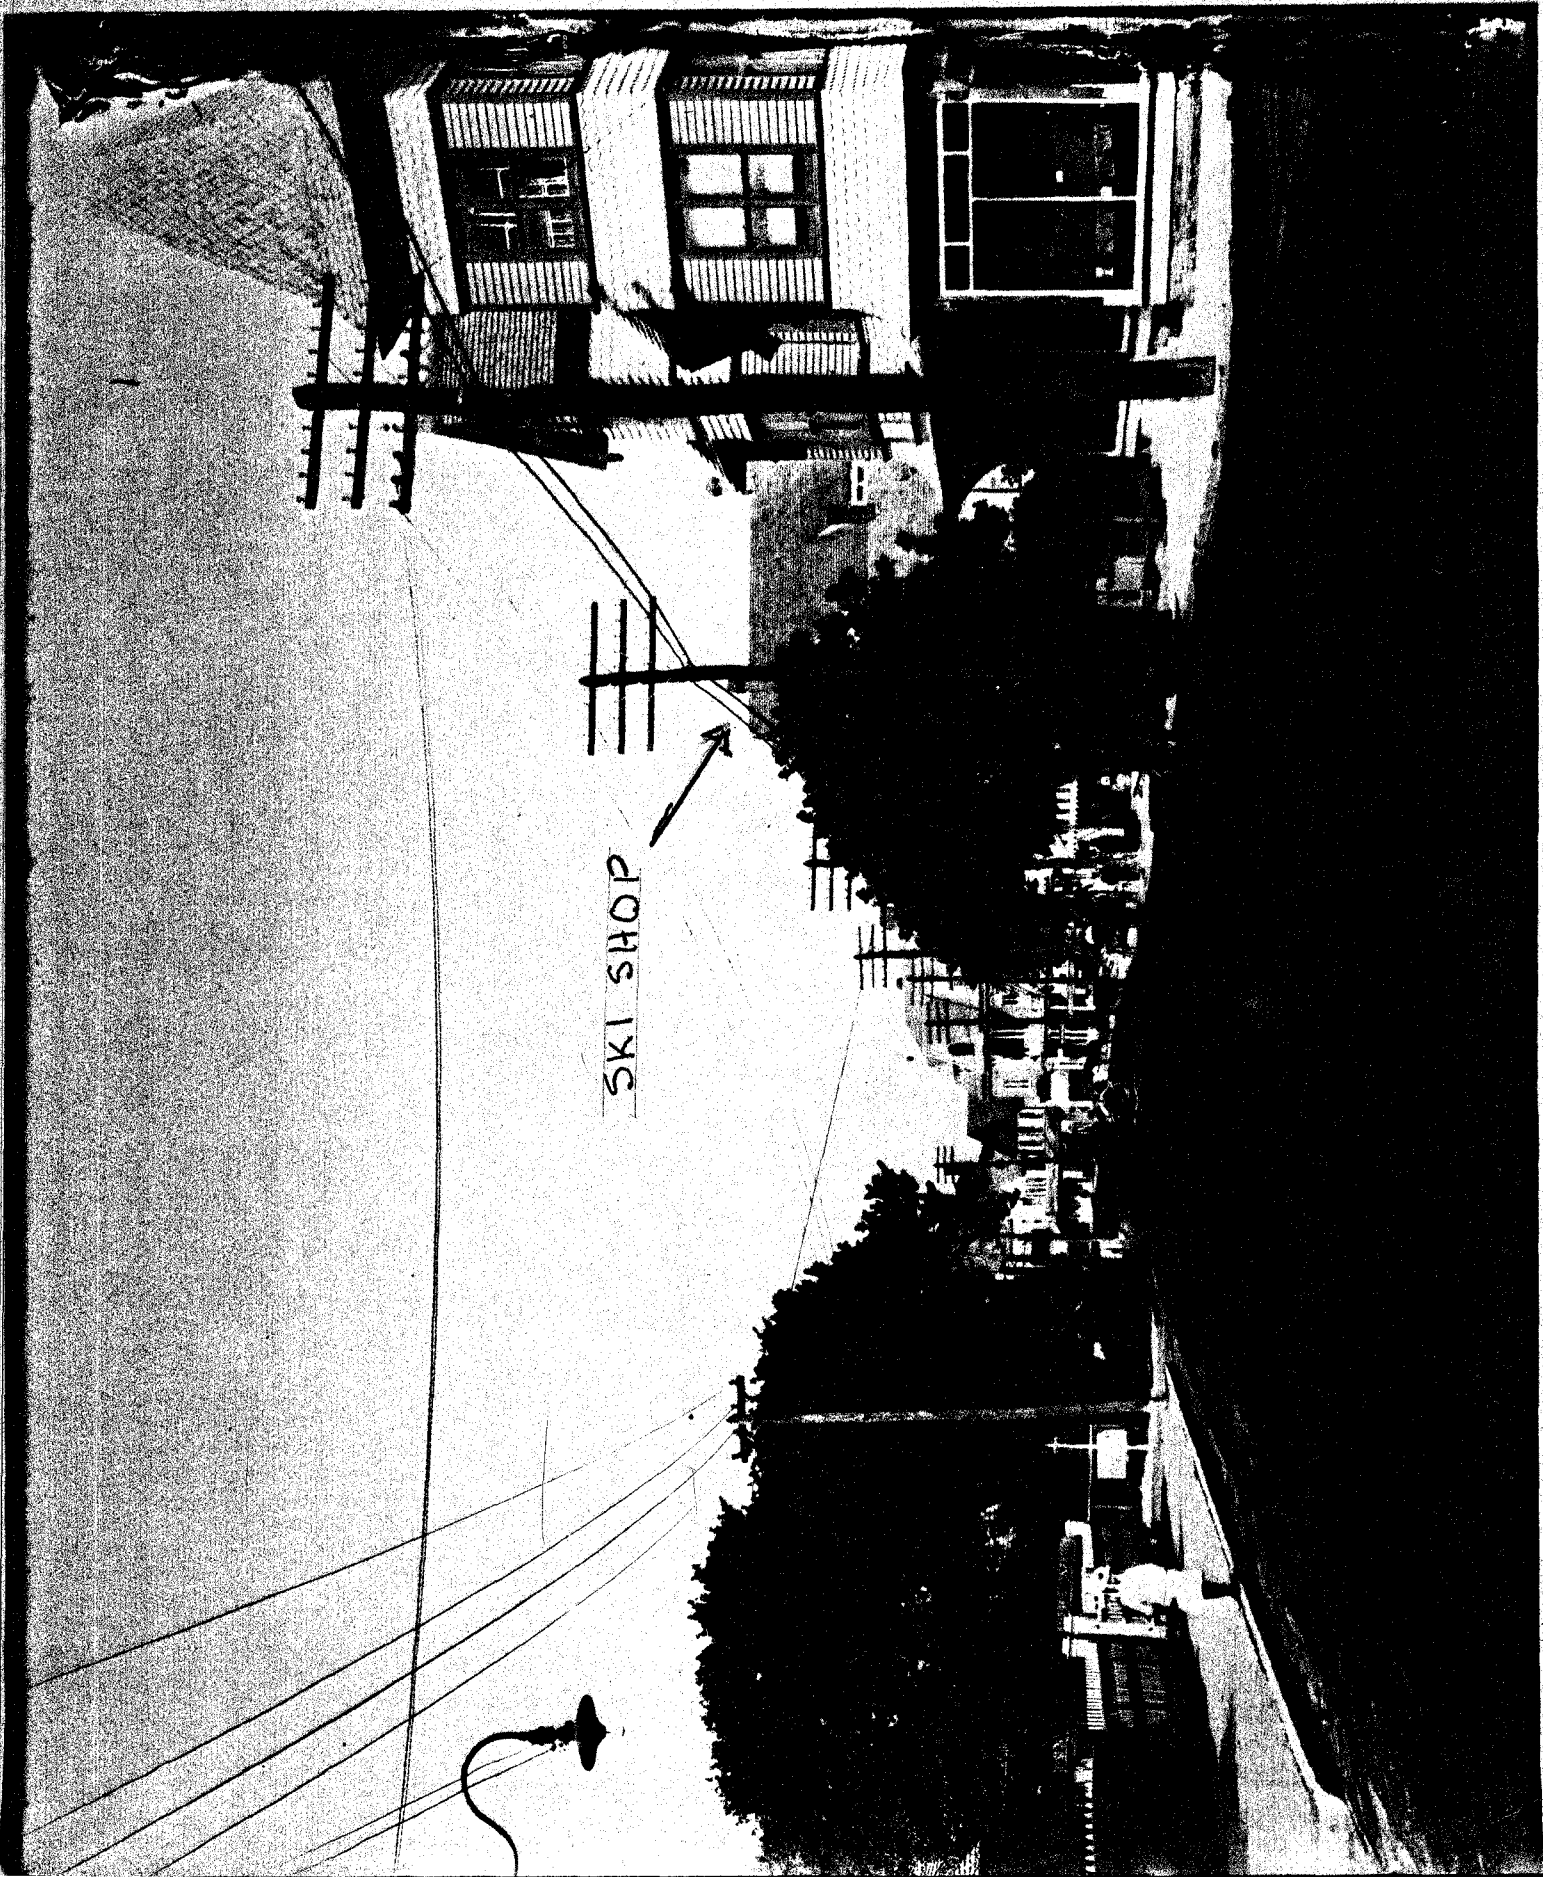
III-4

Old photo by Anderson

Main Street looking east from Ocean Avenue
