BUILDING-STRUCTURE INVENTORY FORM

- 1. BUILDING NAME(S): F. Thurber House
- 2. COUNTY: Suffolk TOWN/CITY: Islip VILLAGE: Bay Shore
- 3. STREET LOCATION: 75 Penataquit Avenue
- 4. OWNERSHIP: a. public b. private
- 5. PRESENT OWNER: _____ ADDRESS: _____
- 6. USE: Original: residence Present: residence
- 7. ACCESSIBILITY TO PUBLIC: Exterior visible from public road: Yes No
Interior accessible: Explain private residence

- 1. BUILDING NAME(S): House at #75 South Penataquit Avenue
- 2. COUNTY: Suffolk TOWN/CITY: Islip VILLAGE: Bay Shore
- 3. STREET LOCATION: #75 S. Penataquit Ave. (east side, north of South Ct.)
- 4. OWNERSHIP: a. public b. private
- 5. PRESENT OWNER: _____ ADDRESS: _____
- 6. USE: Original: Residence Present: Residence
- 7. ACCESSIBILITY TO PUBLIC: Exterior visible from public road: Yes No
Interior accessible: Explain By appointment only

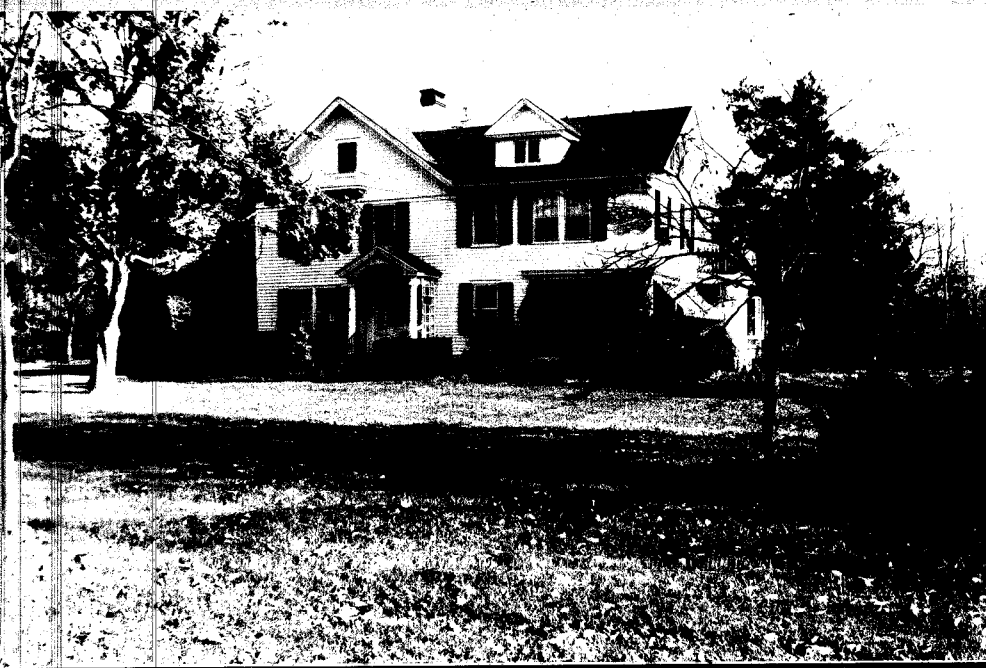
12. PHOTO: Neg. KK III-13, fm. W

- 8. BUILDING MATERIAL: a. clapboard b. stone c. brick d. board and batten
e. cobblestone f. shingles g. stucco other: _____
- 9. STRUCTURAL SYSTEM: a. wood frame with interlocking joints
(if known) b. wood frame with light members
c. masonry load bearing walls
d. metal (explain) _____
e. other _____
- 10. CONDITION: a. excellent b. good c. fair d. deteriorated
- 11. INTEGRITY: a. original site b. moved if so, when? _____
c. list major alterations and dates (if known):
front entrance porch not original

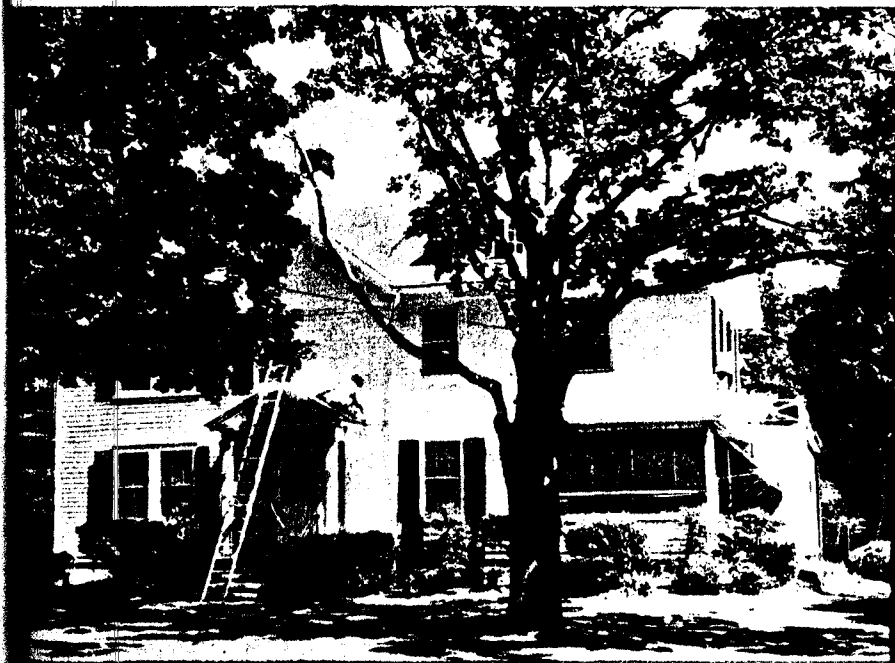
12. PHOTO:

This two and one-half story house with intersecting gables has a mixture of Victorian and Colonial Revival elements. The front entrance has a semi-elliptical fanlight and sidelights, and a one bay gabled entrance porch with classical columns. The gables have fish scale shingles.

This house appears to be ~~an example of the Colonial Revival~~ ⁱⁿ the Colonial Revival Style. The main section's gable faces the street with an intersecting gabled wing on the south side. There is a porte-cochere with classical columns on brick piers on the north side. The gables have fish-scale shingles, and the front gable has a small balustraded balcony. The wing has a front gabled dormer, also shingled, with two six-pane casement windows. The rectangular six-over six windows have simple architraves and lugsills. On the south side, behind the two story wing, is a one story extension with a balustraded terrace on top. The foundation is brick; there is a corbelled chimney.
