BUILDING-STRUCTURE INVENTORY FORM

B-32  
D04

- 1. BUILDING NAME(S): #4 ~~Fourth Avenue~~
- 2. COUNTY: Suffolk TOWN/CITY: Islip VILLAGE: Brentwood
- 3. STREET LOCATION: 4 ~~Fourth Ave.~~ Second St.
- 4. OWNERSHIP: a. public  b. private
- 5. PRESENT OWNER: \_\_\_\_\_ ADDRESS: \_\_\_\_\_
- 6. USE: Original: Residence Present: Residence
- 7. ACCESSIBILITY TO PUBLIC: Exterior visible from public road: Yes  No   
Interior accessible: Explain Privately owned

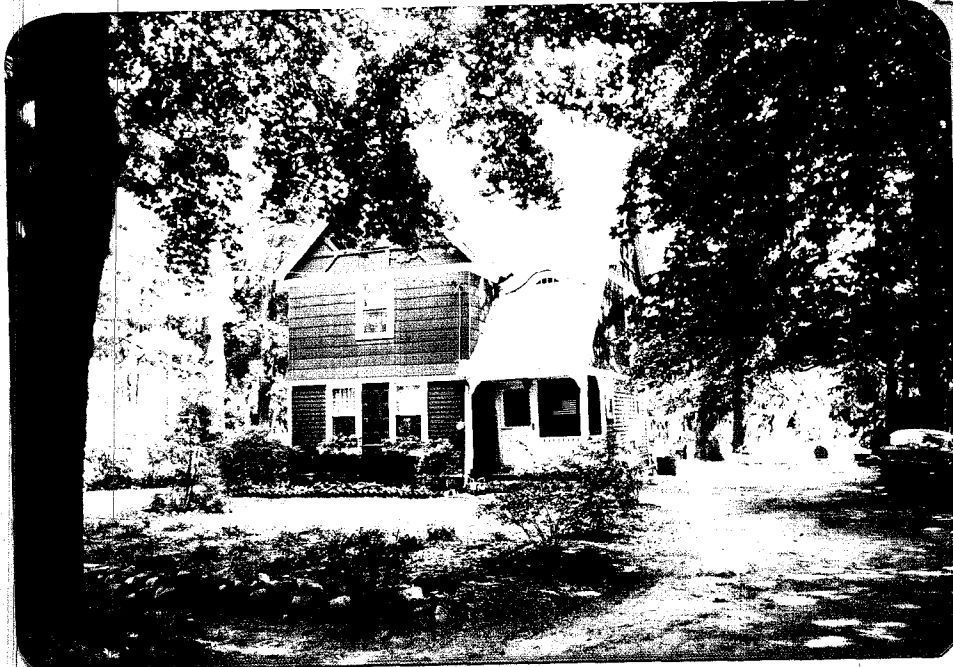
12. PHOTO: Negative No, C-18A

18. OTHER NOTABLE FEATURES OF BUILDING AND SITE (including interior features if known):  
**Gable roof section with half-timbering in gable. Sweeping roof down to porch with eyebrow window. Stickwork panel between to front windows of gable section on first floor. Flaring out of shingles above first floor level. Bay protruding on East facade. Original windows. Queen Anne window in gable.**
