BUILDING-STRUCTURE INVENTORY FORM

- BUILDING NAME(S): Brentwood Lodge & Tollgate
- COUNTY: Suffolk TOWN/CITY: Islip VILLAGE: Brentwood
- STREET LOCATION: Long Island Motor Parkway & Highland
- OWNERSHIP: a. public b. private
- PRESENT OWNER: _____ ADDRESS: _____
- USE: Original: _____ Present: _____
- ACCESSIBILITY TO PUBLIC: Exterior visible from public road: Yes No
Interior accessible: Explain _____

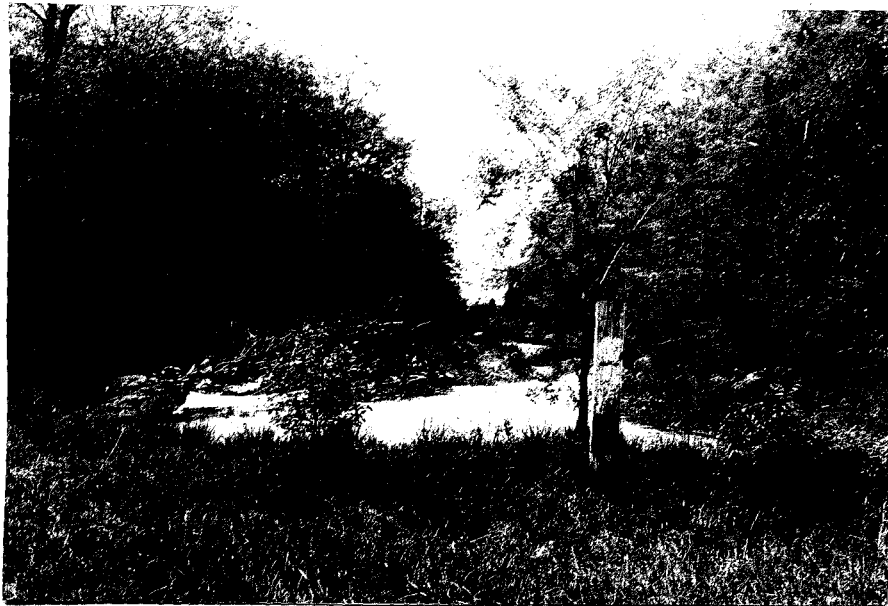
At the end of this unused road is the post seen in Figure 1. The fact that the post is wooden and painted black and white, as well as the length of unpainted wood with nail or screw holes, indicate that perhaps this is the sort of post that the gates shown in Figure 4, Form 3 were attached to.

Figure 1, ETM-6: Frame # 10A. S of the Long Island Expressway, abandoned road parallel to Highland Rd, post possibly related to the Motor Parkway. Looking N.

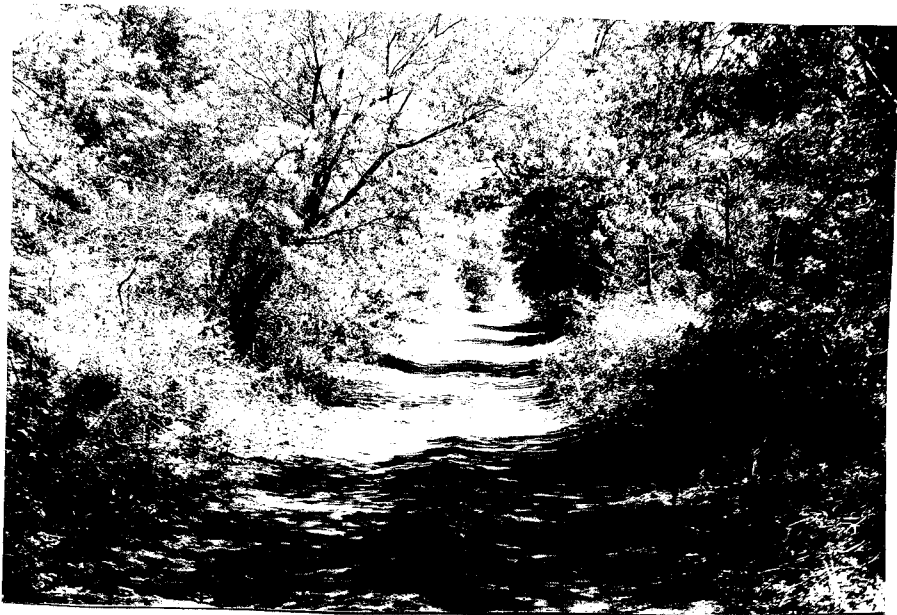
Figure 2.

Figure 2, ETM-6: Frame # 2, Road approaching Building believed to be Brentwood Lodge, looking S. See following page.

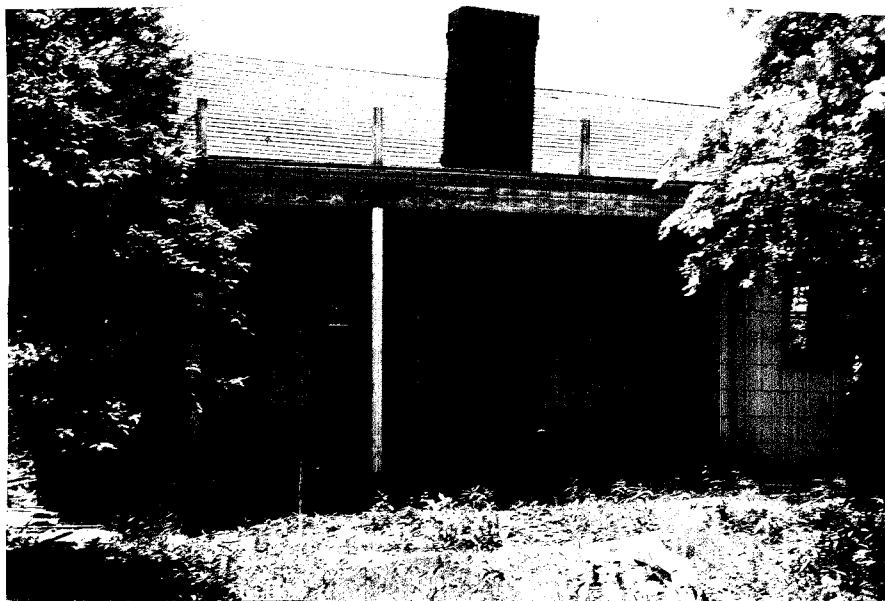
Figure 4, Long Island Motor Parkway facade of above building, looking S.

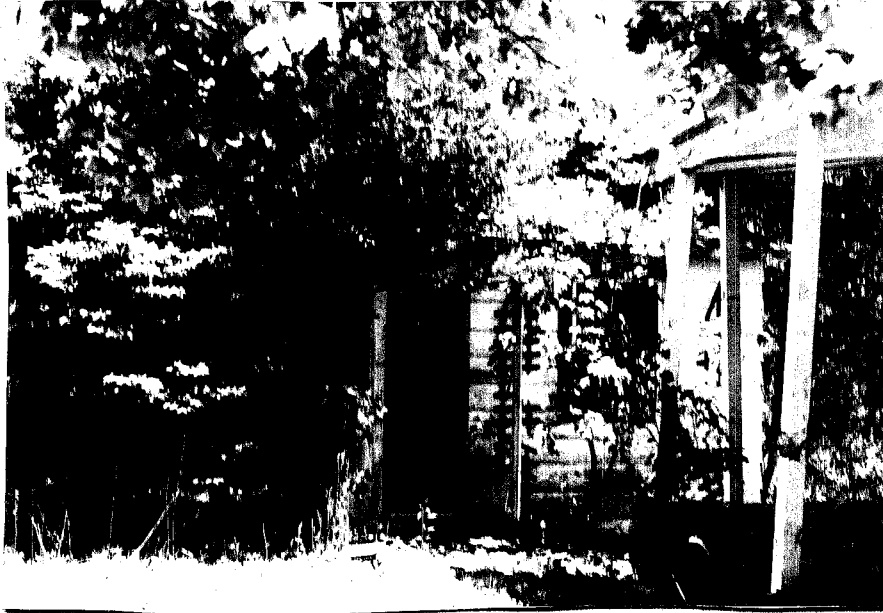
20. A few feet away from the house is a small, square, hip roof building with a door and windows, Figure 5. The side of this building facing the Vanderbilt Parkway has four windows that create one large opening which makes it ideally suited for collecting fares. There is a small, square, protruding front entrance on the Ronkonkoma Logde which might be the incorporation of the toll booth into the lodge.

Figure 6, ETM-6: Frame # 6, Small square building adjacent to house seen in Figures 3 & 4. Looking E.

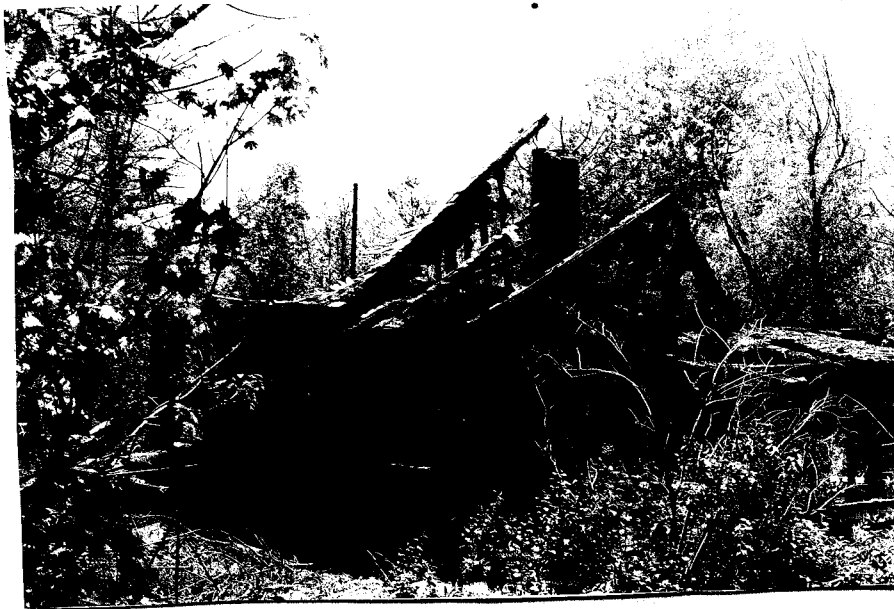
Nearby there is a vacant, burnt house, Figure 6, but the form of the above house and the location of its dependency all appear to suggest that the abandoned house is the lodge.

Figure 7, ETM-6: Frame # 10, Burnt house near probable remains of Brentwood Lodge. Looking S.
