BUILDING-STRUCTURE INVENTORY FORM

DIVISION FOR HISTORIC PRESERVATION
 NEW YORK STATE PARKS AND RECREATION
 ALBANY, NEW YORK (518) 474-0479

1. BUILDING NAME(S): St. John Nepomucene Church
 2. COUNTY: Suffolk TOWN/CITY: Islip VILLAGE: Bohemia
 3. STREET LOCATION: 1150 Locust Ave.
 4. OWNERSHIP: a. public b. private
 5. PRESENT OWNER: _____ ADDRESS: _____
 6. USE: Original: church Present: church
 7. ACCESSIBILITY TO PUBLIC: Exterior visible from public road: Yes No
 Interior accessible: Explain by app't.

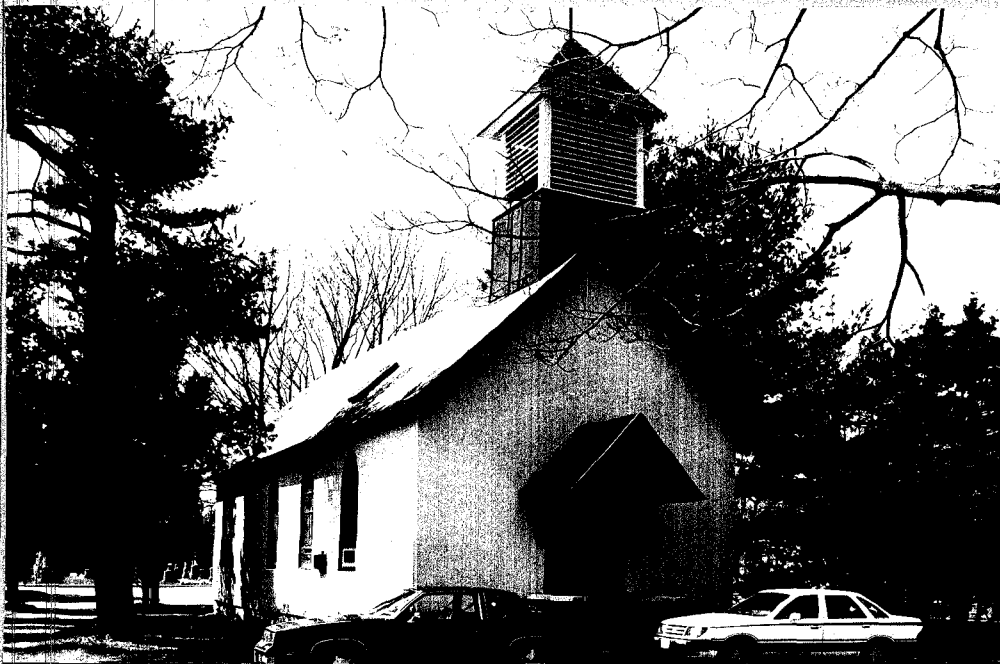
12. PHOTO: Neg. KK XXI-7, fm. E/SE

Enlarged 1922: windows Gothicized, stucco added, structure extended 19 feet.

St. John's Church is a small, 1½ story, stucco, gable roof building with a large square louvered belfry under a pyramidal roof. The gable end facing Locust Avenue is plain stucco. The double leaf entrance door is protected by a gable roof with timber brackets. Windows on the nave walls are in the Gothic pointed arch style.

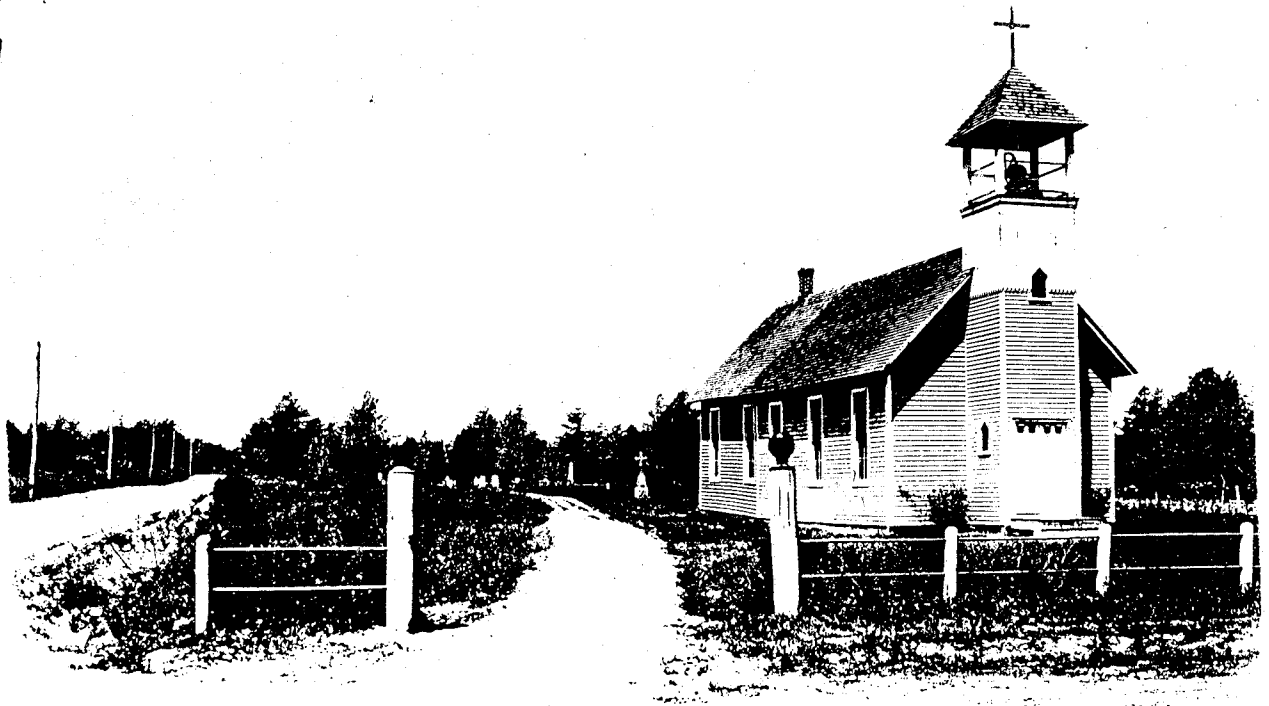
St. John's Church before enlargement and facade renovation.

Korten Photograph, c. 1909, Coll. Nassau County Museum Library.
