**BUILDING-STRUCTURE INVENTORY FORM**

- BUILDING NAME(S): Robbins Hall BIDG. 45
- COUNTY: Suffolk TOWN/CITY: Islip VILLAGE: Central Islip
- STREET LOCATION: east side of Carleton Ave.
- OWNERSHIP: a. public  b. private
- PRESENT OWNER: New York State ADDRESS: \_\_\_\_\_
- USE: Original: auditorium Present: vacant
- ACCESSIBILITY TO PUBLIC: Exterior visible from public road: Yes  No   
Interior accessible: Explain \_\_\_\_\_

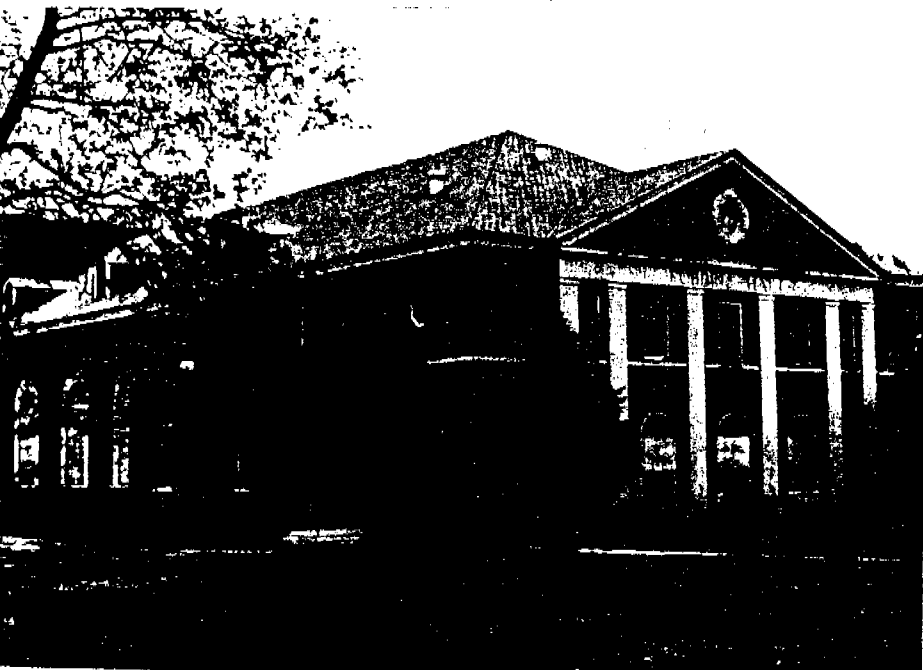
12. PHOTO: CI-WHC-r-1,31 from NW

The building is a large 2-story, hip roof, auditorium building with giant slightly-projecting, pilastered pediment, 5-bay unit on west (entrance) facade, flanked by 1 story, single bay, flat roof unit containing round topped entrance doors with fan shaped transoms, 3 round headed windows on 1st floor of this facade. Oculus in pediment with high relief scrolled enframement. On north and south facades there are 5 large round headed windows.
