**BUILDING-STRUCTURE INVENTORY FORM**

- 1. BUILDING NAME(S): Hoppin Female, Building 95 (AKA 25)
- 2. COUNTY: Suffolk TOWN/CITY: Islip VILLAGE: Central Islip
- 3. STREET LOCATION: east side of Carleton Ave.
- 4. OWNERSHIP: a. public  b. private
- 5. PRESENT OWNER: New York State ADDRESS: \_\_\_\_\_
- 6. USE: Original: Female housing Present: same
- 7. ACCESSIBILITY TO PUBLIC: Exterior visible from public road: Yes  No   
Interior accessible: Explain \_\_\_\_\_

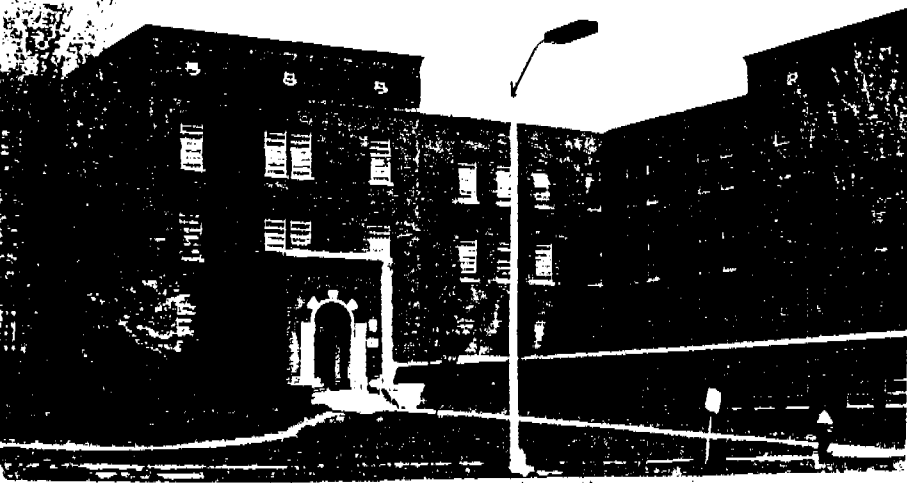
12. PHOTO: CI-WHC-r-1,13 from NW

The building is a 4 story and basement, hip roof main section facing the west with articulated brick cornice- ~~with~~<sup>no</sup> flat roofed wings on east(kitchen) on north and on south. Two wings projecting to the west are characterized by inserted square hip-roof units with matching articulated brick cornices and round windows(oculi) in frieze stories. The projecting 1-story brick entrance with parapet roof has round - headed recessed doorway with decorative voussoirs and pilasters.

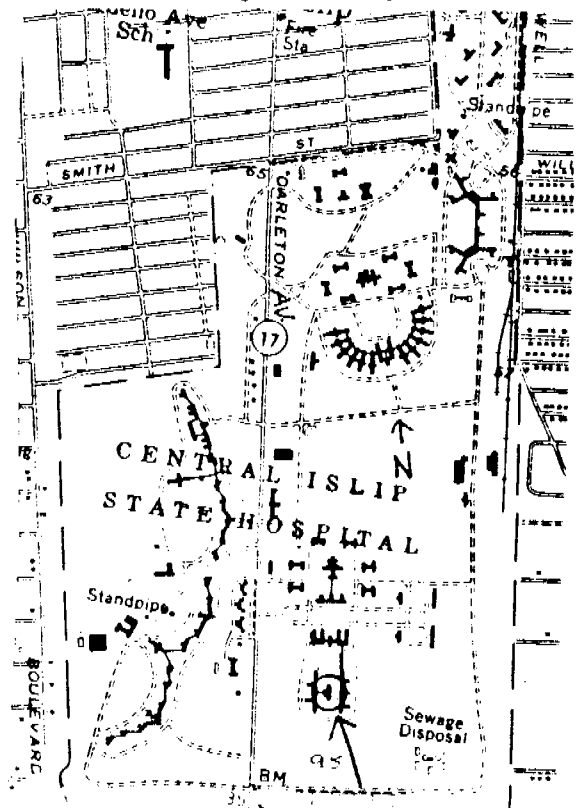
The building is located on the east side of Carleton Ave. and is surrounded by two other large buildings.
