BUILDING-STRUCTURE INVENTORY FORM

YOUR NAME: Town of Islip DATE: September 23, 1975

- 1. BUILDING NAME(S): Central Islip State Hospital's Mat Shop; Formerly Power House
- 2. COUNTY: Suffolk TOWN/CITY: Islip VILLAGE: Central Islip House
- 3. STREET LOCATION: West of Carleton Avenue, on access road
- 4. OWNERSHIP: a. public b. private
- 5. PRESENT OWNER: _____ ADDRESS: _____
- 6. USE: Original: Power House Present: Mat Shop
- 7. ACCESSIBILITY TO PUBLIC: Exterior visible from public road: Yes No
Interior accessible: Explain By appointment only
Permission necessary for entering grounds.

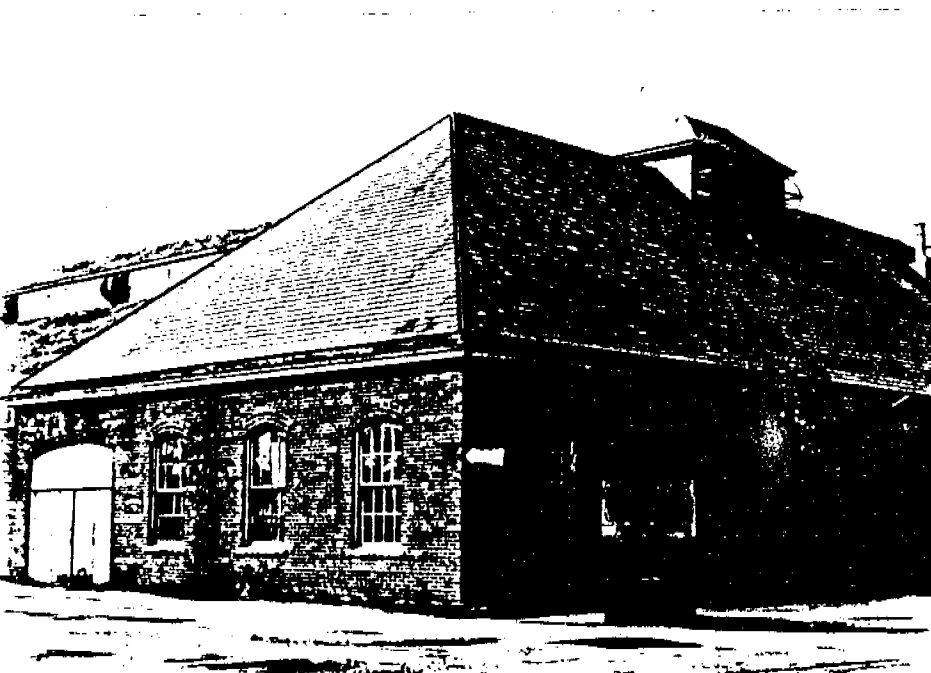
12. PHOTO:

Many windows filled in and entrances altered.
Some newer additions.

This building is comprised of several intersecting units. They are primarily hip roofed, with one section having a gabled roof with return cornice. There are hip roofed dormers, including one long dormer straddling the roof ridge. (clearestory)

This building was originally the power house for the Central Islip State Hospital. The structure is brick with brick buttressing. It has segmental arched windows with three courses of brick outlining the heads. Some of the windows are eight-over-eight; others are six-over-six. The ~~original~~ windows have stone lugsills. Part of the original slate roof remains in tact. While the doorways have generally undergone alterations, they too are segmental arched with 3 courses of brick heads outlining the arch.

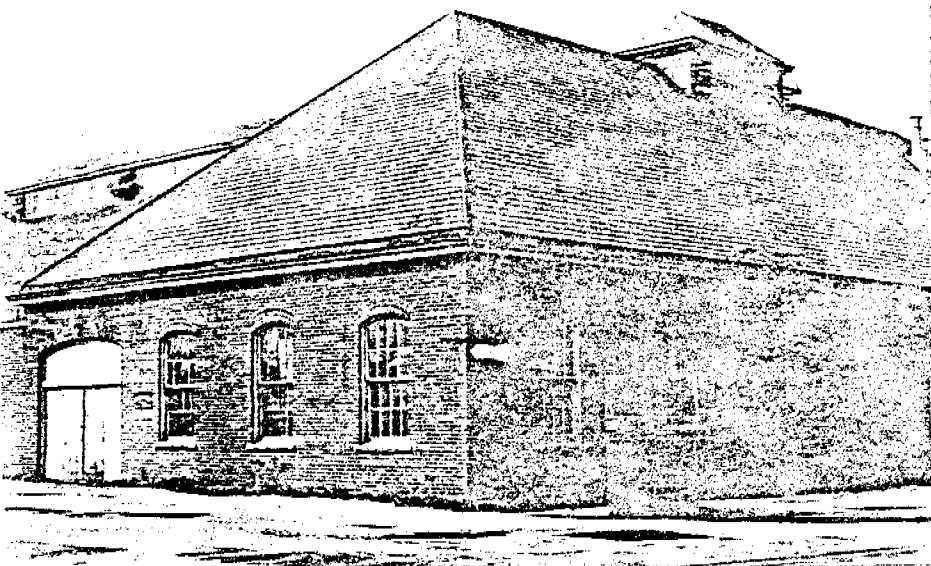
HP-1 Roll #Q7; Negative #5
South & East sides.

Many windows filled in and entrances altered.
Some newer additions.

18. OTHER NOTABLE FEATURES OF BUILDING AND SITE (including interior features if known):
 This building is comprised of several intersecting units. They are primarily hip roofed, with one section having a gabled roof with return cornice. There are hip roofed dormers, including one long dormer straddling the roof ridge. (clevestory)

20. HISTORICAL AND ARCHITECTURAL IMPORTANCE: (clevestory)
 This building was originally the power house for the Central Islip State Hospital. The structure is brick with brick buttressing. It has segmental arched windows with three courses of brick outlining the heads. Some of the windows are eight-over-eight; others are six-over-six. The six-over-six windows have stone lugsills. Part of the original slate roof remains in tact. While the doorways have generally undergone alterations, they too are segmental arched with 3 courses of brick heads outlining the arch.
