BUILDING-STRUCTURE INVENTORY FORM

DIVISION FOR HISTORIC PRESERVATION  
NEW YORK STATE PARKS AND RECREATION  
ALBANY, NEW YORK (518) 474-0479

- 1. BUILDING NAME(S): Dana House
- 2. COUNTY: Suffolk TOWN/CITY: Islip VILLAGE: Islip
- 3. STREET LOCATION: 11 Dana Lane
- 4. OWNERSHIP: a. public  b. private
- 5. PRESENT OWNER: Bery Beyrer ADDRESS: 11 Dana Lane
- 6. USE: Original: residence Present: residence
- 7. ACCESSIBILITY TO PUBLIC: Exterior visible from public road: Yes  No   
Interior accessible: Explain \_\_\_\_\_

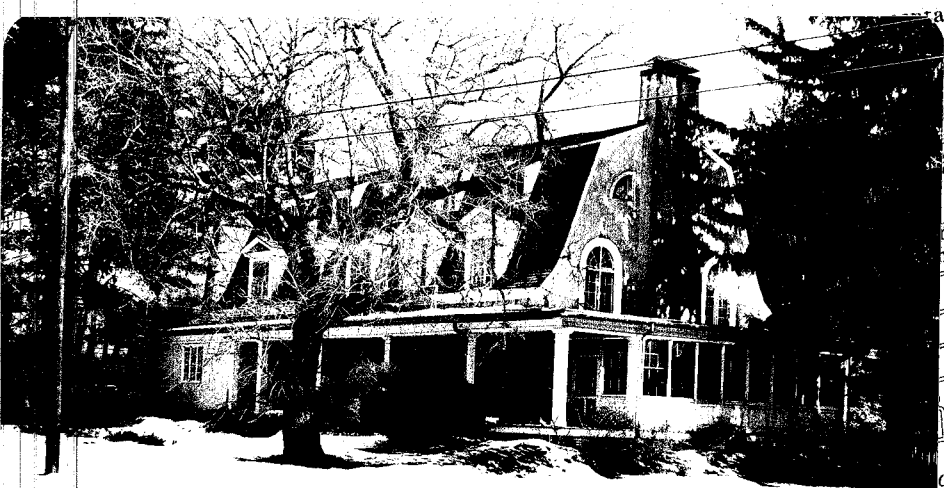
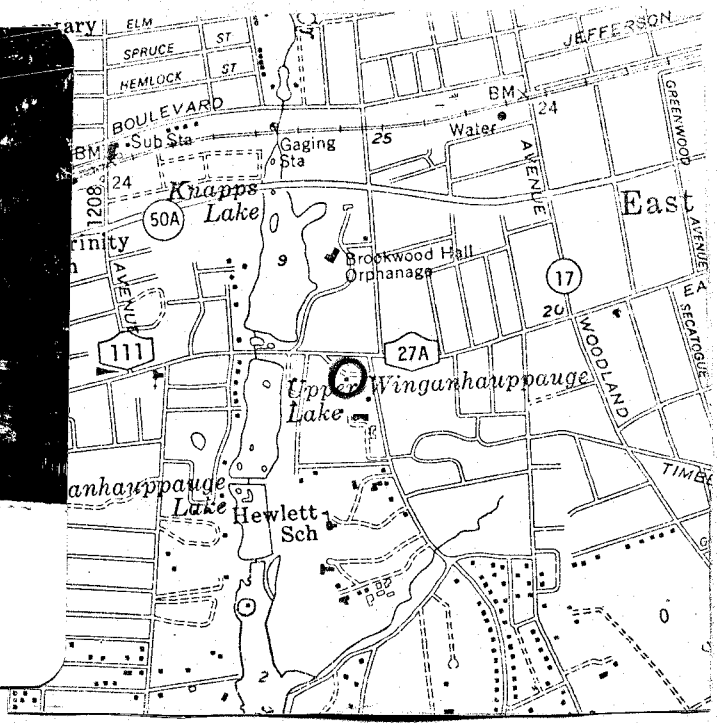
HP-1 Looking Northeast

Stucco house has gambrel roof and Colonial Revival entrance with sidelights. There is one end chimney and the original porch has been enclosed on the North end. 2nd floor windows have arched tops on South side. The 5 pedimented dormers on the 2nd floor have casement windows the center dormer has segmental arched pediment with decoration.

arcaded cornice with dentil course

3rd floor quadrant windows

3rd floor has 5 shed roofed dormers above 2nd floor dormers
