**BUILDING-STRUCTURE INVENTORY FORM**

1. BUILDING NAME(S): ~~Bar House~~  
 2. COUNTY: Suffolk TOWN/CITY: Islip VILLAGE: Oakdale  
 3. STREET LOCATION: 959 Montauk Highway Hwy  
 4. OWNERSHIP: a. public  b. private   
 5. PRESENT OWNER: \_\_\_\_\_ ADDRESS: \_\_\_\_\_  
 6. USE: Original: residence Present: residence  
 7. ACCESSIBILITY TO PUBLIC: Exterior visible from public road: Yes  No   
 Interior accessible: Explain \_\_\_\_\_

The Burr House is located on the north side of Montauk Hwy.,  
to the east of the Ockers House (Oa 40).

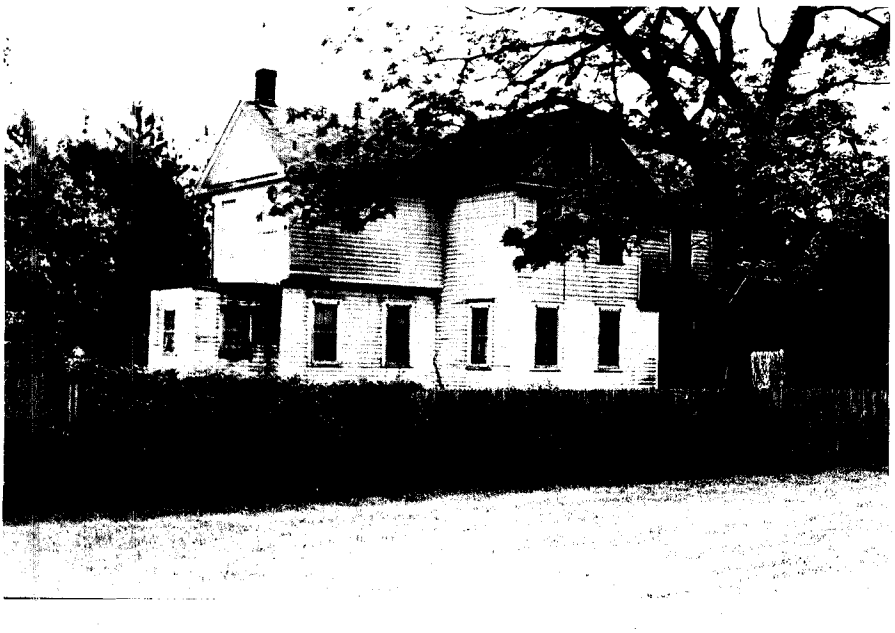
12. PHOTO: Neg. 3a, NJM-2  
view from northwest

*c 1992: Completely sided/rewindowed  
w/nyl*

2½ story cross-shaped wood house, with wraparound porch with  
turned posts. Gable end to the street with scalloped shingles  
and a round topped window. Windows are 2/2.
