BUILDING-STRUCTURE INVENTORY FORM

- 1. BUILDING NAME(S): Garber House (c. 1888)
- 2. COUNTY: Suffolk TOWN/CITY: Islip VILLAGE: Sayville
- 3. STREET LOCATION: 178 Middle Road
- 4. OWNERSHIP: a. public b. private
- 5. PRESENT OWNER: _____ ADDRESS: _____
- 6. USE: Original: residence Present: residence
- 7. ACCESSIBILITY TO PUBLIC: Exterior visible from public road: Yes No
Interior accessible: Explain _____

Prepared by: Society for the Preservation of Long Island Antiquities
 Setauket, New York 11733
 Nina Monastero, Research Assistant
 August, 1979

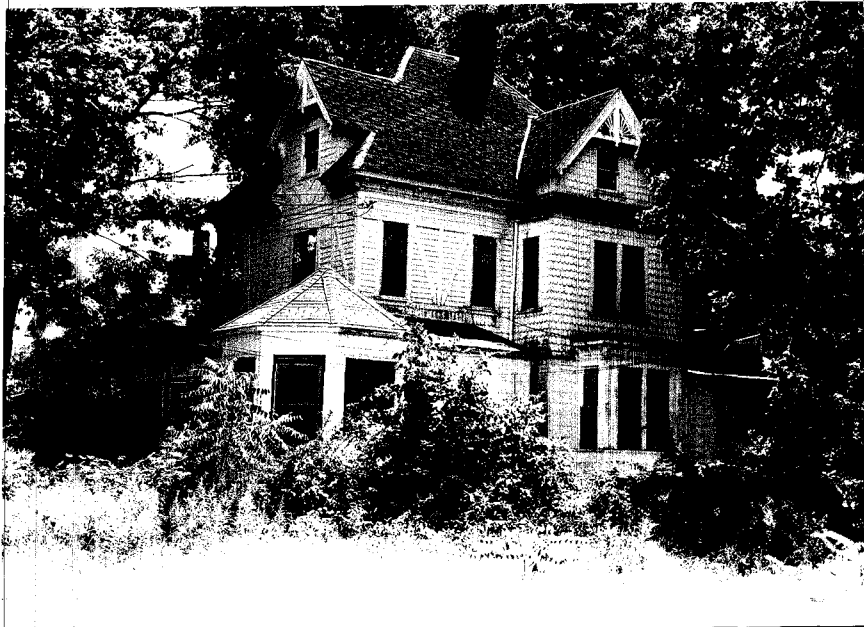
HP-1 view from northwest

2½ story stick style house with high hip roof and corbelled brick chimney. Stained glass windows in upper sash, variegated shingles and clapboards, decorative sunburst in gable head. Porch has octagonal pavillion, Queen Anne infill in dormer.

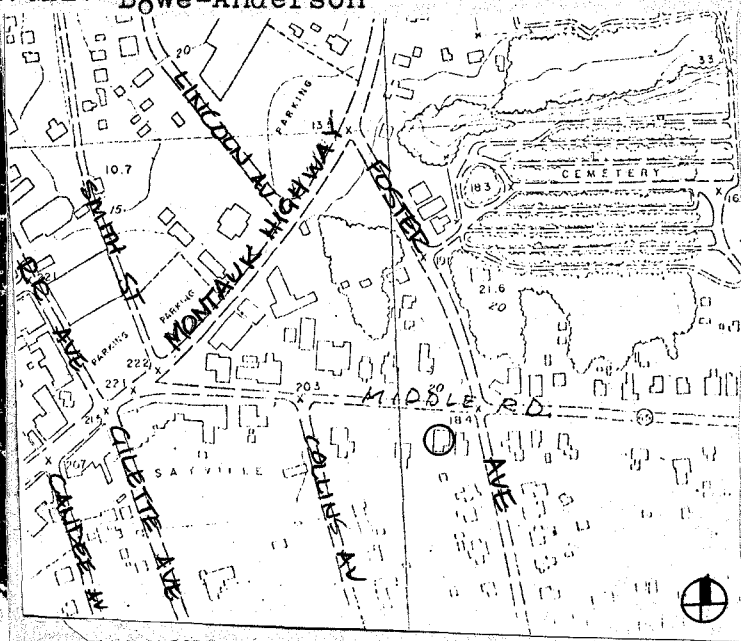
13. MAP: Bowe-Anderson

The Garber House is located on the south side of Middle Road, near Foster Avenue.

The Garber house is directly opposite Sa 46.
