**BUILDING-STRUCTURE INVENTORY FORM**

YOUR NAME: Town of Islip/SPLIA DATE: February 1990

ORGANIZATION (if any): Dept. of Planning, Housing, and Development

- 1. BUILDING NAME(S): Fifth Avenue School
- 2. COUNTY: Suffolk TOWN/CITY: Islip VILLAGE: Bay Shore
- 3. STREET LOCATION: Fifth Ave., east side, SE corner Sunrise Hwy. cloverleaf
- 4. OWNERSHIP: a. public  b. private
- 5. PRESENT OWNER: \_\_\_\_\_ ADDRESS: \_\_\_\_\_
- 6. USE: Original: school Present: school
- 7. ACCESSIBILITY TO PUBLIC: Exterior visible from public road: Yes  No   
Interior accessible: Explain by appointment

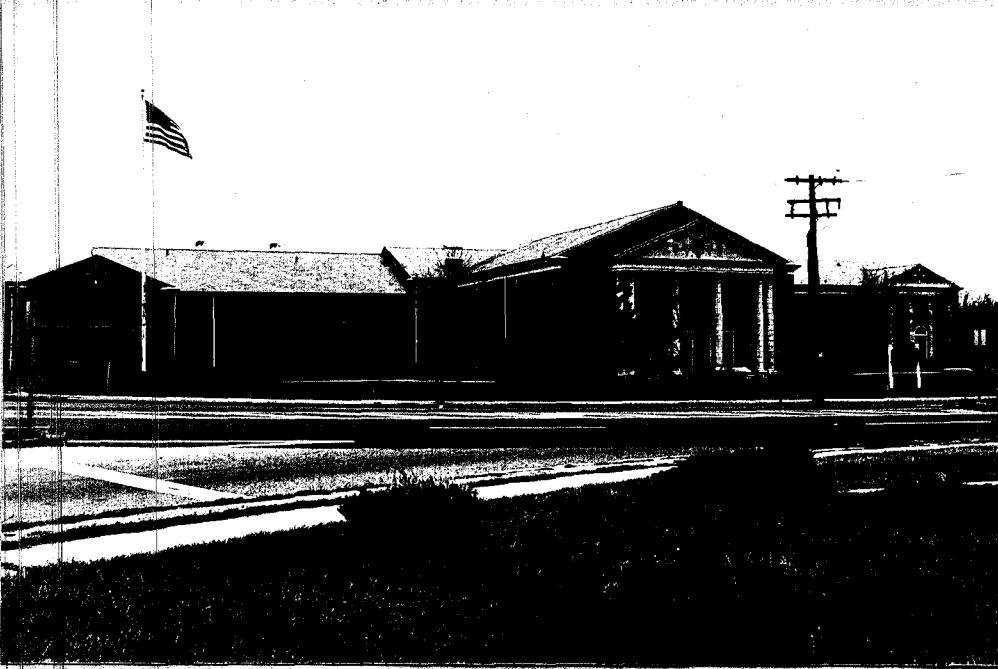
12. PHOTO: Neg. KK VI-11, fm. NW

Identical to the nearby Brook Avenue School (BS 61), the Fifth Avenue School is a large, 2½ story, brick, Georgian Revival-style building with a two story portico at the entrance wing. This wing features fluted Corinthian columns and a pediment with terra cotta cartouche and swags over three round arch entrance doors. Central wing with round SIGNIFICANCE arch windows.
