BUILDING-STRUCTURE INVENTORY FORM

YOUR NAME: Town of Islip DATE: August 15, 1975
Town Hall
YOUR ADDRESS: 655 Main Street TELEPHONE: (516) 581-2000
ORGANIZATION (if any): Department of Planning, Housing & Development

- 1. BUILDING NAME(S): Tudor Inn; previously Heuer Grocery Store
- 2. COUNTY: Suffolk TOWN/CITY: Islip VILLAGE: Bay Shore
- 3. STREET LOCATION: 42 Main St. Shore Ave.
- 4. OWNERSHIP: a. public b. private #42
- 5. PRESENT OWNER: _____ ADDRESS: _____
- 6. USE: Original: Residence? Present: Restaurant/Bar
- 7. ACCESSIBILITY TO PUBLIC: Exterior visible from public road: Yes No
Interior accessible: Explain During business hours.

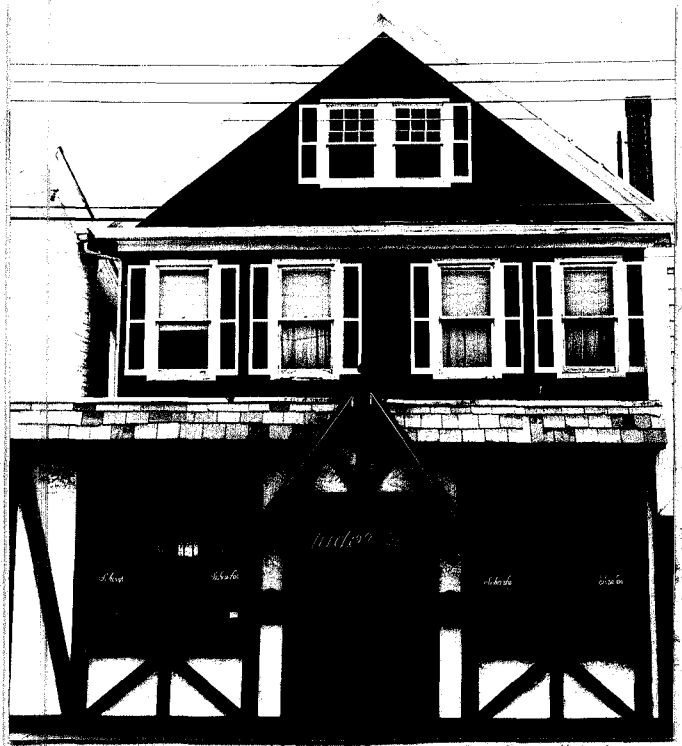
Bay Shore Roll #Q4; Neg.#7
HP-1 Front (north) facade.

This two and one-half story structure has a gable roof. There is a twin rectangular window in the gable; the sashes are nine over one. The windows in the rear are two over two. There is a cornice above the second story.

This structure is one of the few gable roofed buildings remaining on Main Street. It is two and one-half stories high and four bays wide. While the first floor has been remodelled "Tudor Style," with stucco and stickwork, the upper stories retain their old appearance. The surface material is rectangular shingle; the rectangular windows have simple architraves. The gable side of the structure faces the street; the cornice is boxed and pedimented.
