BUILDING-STRUCTURE INVENTORY FORM

DIVISION FOR HISTORIC PRESERVATION
NEW YORK STATE PARKS AND RECREATION
ALBANY, NEW YORK (518) 474-0479

- 1. BUILDING NAME(S): _____
- 2. COUNTY: Suffolk TOWN/CITY: Islip VILLAGE: Bay Shore
- 3. STREET LOCATION: #180 E. Main St. (south side of Main, East of Homan Ave.)
- 4. OWNERSHIP: a. public b. private
- 5. PRESENT OWNER: _____ ADDRESS: _____
- 6. USE: Original: Residence? Present: Antique Store
- 7. ACCESSIBILITY TO PUBLIC: Exterior visible from public road: Yes No
Interior accessible: Explain During store hours.

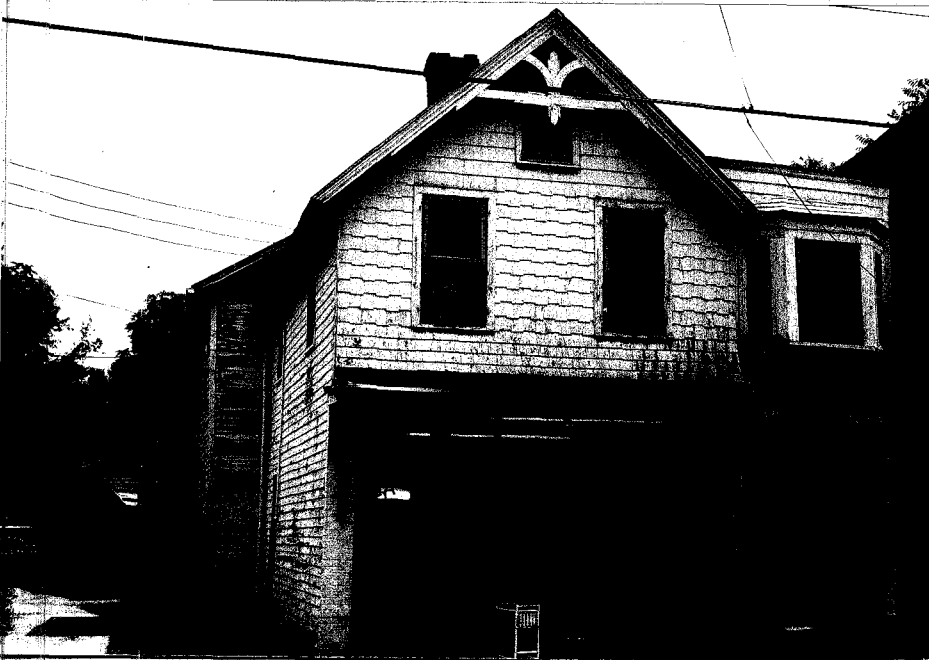
12. PHOTO:

Bay Shore Roll #Q4; Neg. #16.
HP-1 North (front) & East Sides.

This gable roofed structure has stickwork in its front gable. There is an oriel window supported by a corbel at the west side of the front facade. This window has some diamond-paned stained glass. In the gable, the rectangular shingles run straight across; below this, they alternate up and down.

This building is one of the few remaining Victorian structures on Main Street. It has mixed use of surface materials - rectangular shingles in varying patterns on the front facade, and clapboard on the side. It also retains its oriel window with diamond panes, and its stickwork in the gable. There is a corbelled chimney in the rear center of the building. The site was part of the property of Joseph Robbins in 1915.
