BUILDING-STRUCTURE INVENTORY FORM

YOUR NAME: Town of Islip DATE: August 15, 1975

ORGANIZATION (if any): Department of Planning, Housing, & Development

- 1. BUILDING NAME(S): Bay Shore Fire Department
- 2. COUNTY: Suffolk TOWN/CITY: Islip VILLAGE: Bay Shore
- 3. STREET LOCATION: Main Street south side bet. Maple Ave. & Shore Ave.
- 4. OWNERSHIP: a. public b. private
- 5. PRESENT OWNER: _____ ADDRESS: _____
- 6. USE: Original: Fire Department Present: Fire Department
- 7. ACCESSIBILITY TO PUBLIC: Exterior visible from public road: Yes No
Interior accessible: Explain By appointment only

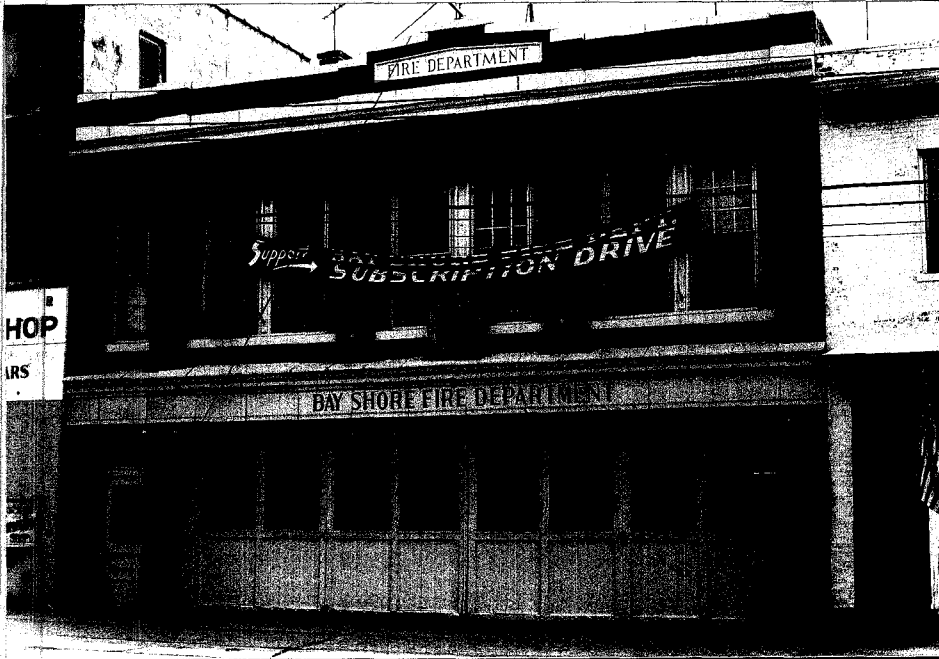
12. PHOTO:

First floor remodelled - new doors with glass.

HP-1 Bay Shore Roll #Q4; Neg. #9
Front (north) facade

18. OTHER NOTABLE FEATURES OF BUILDING AND SITE (including interior features if known):
This two story yellow-brown brick structure is four bays wide. The east bay is very narrow; it has a window with a lugsill on the second floor, and a door on the first. The wide bays have two windows per bay - double hung sash with molding between the windows.

Despite alterations, this firehouse retains much of the aura and detail of the original. The two story brick structure has a parapet, cornice, and decorative pattern in brick above the second story windows. There are five pilasters framing the four bays.

The building had a fire about 1926; the first floor was subsequently remodelled, removing the pilasters.
