BUILDING-STRUCTURE INVENTORY FORM

* * * * * * * *	
IDENTIFICATION	E(S): House at #59 Maple Avenue
1. BUILDING NAME	(S): Total and Talling Classes
2. COUNTY: <u>Sul</u>	Productive Town/City; Islip VILLAGE: Bay Shore
	ON: \$59 Maple Ave. (East sode, south of Maple Court)

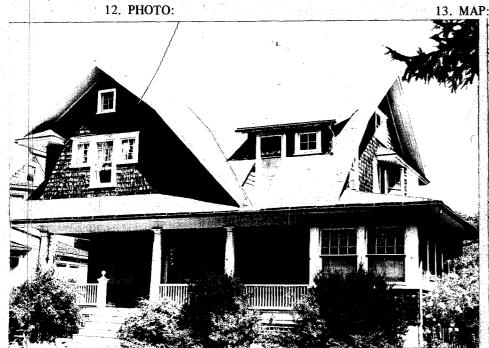
HP-1 Bay Shore Roll #Q6; Neg. #8

18.	OTHER NOTABLE FEATURES OF BUILDING AND SITE (including interior features if known):
TI	ne house retains its original windows. There are two twelve-over- ne windows at the south end of the front facade. The front gable
ho	as a nine-over-one window flanked by six lights on each side (two
117	de, three long). The north side has a round headed window with
ar	ornamental design, and shingles outlining the circular head.
	de la company de
	NIFICANCE

19.	DATE OF INITIAL CONSTRUCTION: unknown
	ARCHITECT: unknown
	ARCHITEUT:
	BUILDER: unknown
	BOILDER
20	HISTORICAL AND ARCHITECTURAL IMPORTANCE:
	is house has an unusual combination of gable and gambrel roof
tv	pes, with a return on the gable side. The roof line is repeated
	the large front dormer. There is a wide overhang. The front
pg	rch has classical columns and a simple balustrade. There are
sе	veral types of original windows, the predominant type being
	ctangular with simple architraves. (the multi-paned types and
ro	und-headed window are described above) On the south side below
	e cornice there is a second story bay window. The front facade
ha	s a shed roof dormer.
	is may have been the E.R. Udall House in 1915. SOURCES:
Secretarial and an artist of the	las of the Ocean Shore of Suffolk County, L.I. (Westerly Section).
$\overline{\mathbb{B}}$ r	ooklyn & Manhattan: E. Belcher Hyde, 1915. Volume I. Plate 21.

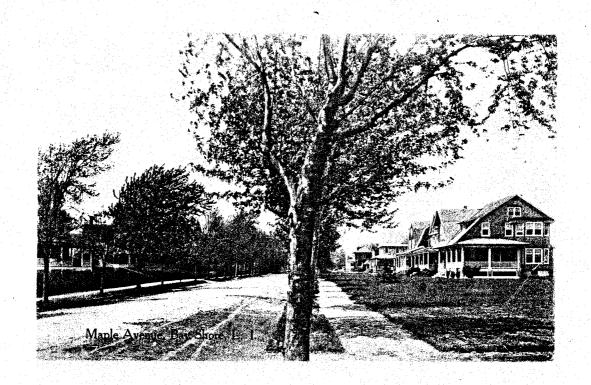
OID POSTAL CARD - LOOKING NORTH

59 MAPLE AVENDE AT RIGHT
