**BUILDING-STRUCTURE INVENTORY FORM**

YOUR NAME: Town of Islip DATE: August 8, 1975  
Town Hall

- 1. BUILDING NAME(S): 1915 ~~Harry Hooper House~~ ; ~~Centennial Realty (1975)~~
- 2. COUNTY: Suffolk TOWN/CITY: Islip VILLAGE: Bay Shore
- 3. STREET LOCATION: #6 Ocean Ave. (west side, bet. Main St. & Gibson St.)
- 4. OWNERSHIP: a. public  b. private
- 5. PRESENT OWNER: \_\_\_\_\_ ADDRESS: \_\_\_\_\_
- 6. USE: Original: Residence Present: Realty Company
- 7. ACCESSIBILITY TO PUBLIC: Exterior visible from public road: Yes  No   
Interior accessible: Explain During Office Hours.

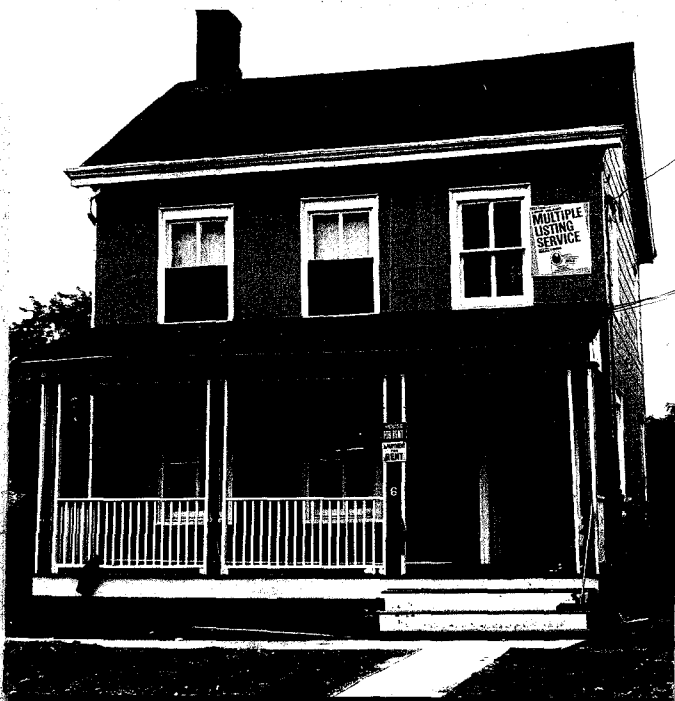
18. OTHER NOTABLE FEATURES OF BUILDING AND SITE (including interior features if known):  
This three bay, two and one-half story structure has a gable roof; the gables at the sides of the house. The three bay front porch has openwork, turned posts, and a simple balustrade. The porch eaves expose extended rafter ends. The windows are original; they are two over two with simple architraves.

This structure, a house transformed into a place of business, has some of its original detailing. The dominant element is the front porch with its jigsaw scrollwork, and extended rafters at the eaves. The roof cornice of the house is boxed. The front doorway has a simple architrave and is recessed approximately one foot. Interesting open-work porch columns, typical pre-Civil War.
