BUILDING-STRUCTURE INVENTORY FORM

YOUR NAME: Town of Islip DATE: August 29, 1975
Town Hall
YOUR ADDRESS: 655 Main Street TELEPHONE: (516) 581-2000

- 1. BUILDING NAME(S): _____
- 2. COUNTY: Suffolk TOWN/CITY: Islip VILLAGE: Bay Shore
- 3. STREET LOCATION: #91 Ocean Ave. (east side, south of Linden Place)
- 4. OWNERSHIP: a. public b. private
- 5. PRESENT OWNER: _____ ADDRESS: _____
- 6. USE: Original: Residence Present: Residence
- 7. ACCESSIBILITY TO PUBLIC: Exterior visible from public road: Yes No
Interior accessible: Explain BY appointment only.

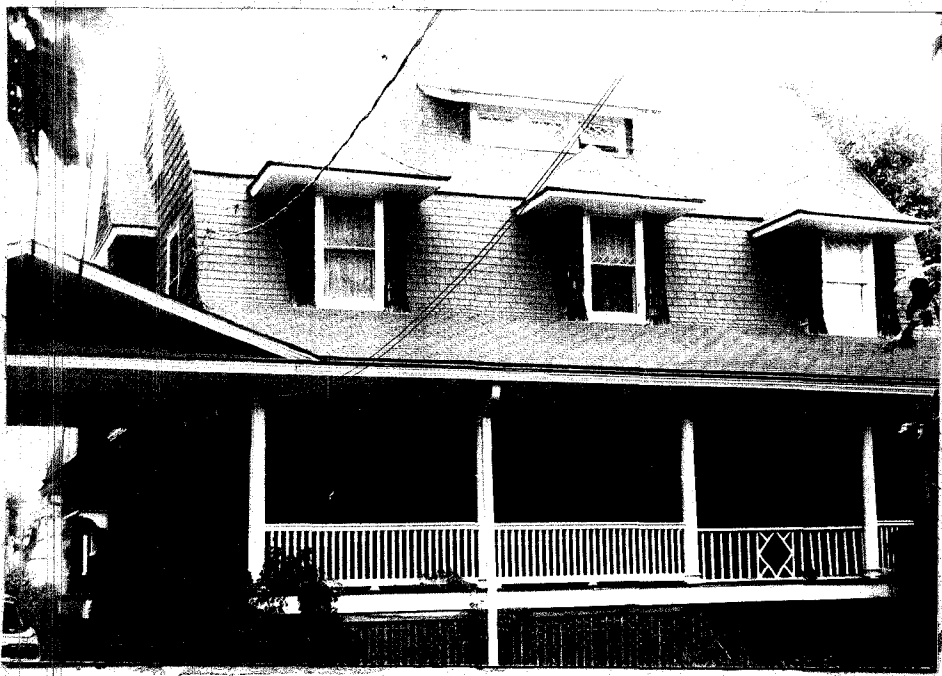
HP-1 Bay Shore Roll #Q5; Neg. #15
Front (west) Facade

18. OTHER NOTABLE FEATURES OF BUILDING AND SITE (including interior features if known):
 This Dutch Colonial Revival House has a gambrel roof and three front dormers capped with overhanging, curved and pointed roofs. There are pointed panes in the upper sash of the dormer windows. There is a shed-roofed dormer with three diamond paned casements above the major dormers. The wing in the rear also has its original dormers.

20. HISTORICAL AND ARCHITECTURAL IMPORTANCE:
 This house is a fine example of the Dutch Colonial Revival style. There is an original front porch and pedimented porte-cochere with wooden columns supported on brick piers. The back porch has a trellis. The north side has a projecting bay with brackets, and dormers. The upper sash of the north gable window has diamond-shaped panes. The north side's projecting bay has a casement window with pointed panes; there are diamond shaped shingles in the gable of this projecting bay. There is a small diamond-paned window below this bay. The south side has a projecting bay window. The porte-cochere has trelliswork. First floor windows are shuttered. The house's main section has a central chimney; the foundation is brick.
