**BUILDING-STRUCTURE INVENTORY FORM**

YOUR NAME: Town of Islip DATE: August 25, 1975

- 1. BUILDING NAME(S): Formerly Ed. Robbins House; Mrs. Daggart House
- 2. COUNTY: Suffolk TOWN/CITY: Islip VILLAGE: Bay Shore
- 3. STREET LOCATION: #27 Shore Lane (east side, bet. Gibson St. & Maple Ct.)
- 4. OWNERSHIP: a. public  b. private
- 5. PRESENT OWNER: Mack ADDRESS: 25 Shore Lane
- 6. USE: Original: Residence Present: Residence
- 7. ACCESSIBILITY TO PUBLIC: Exterior visible from public road: Yes  No   
Interior accessible: Explain By appointment only.

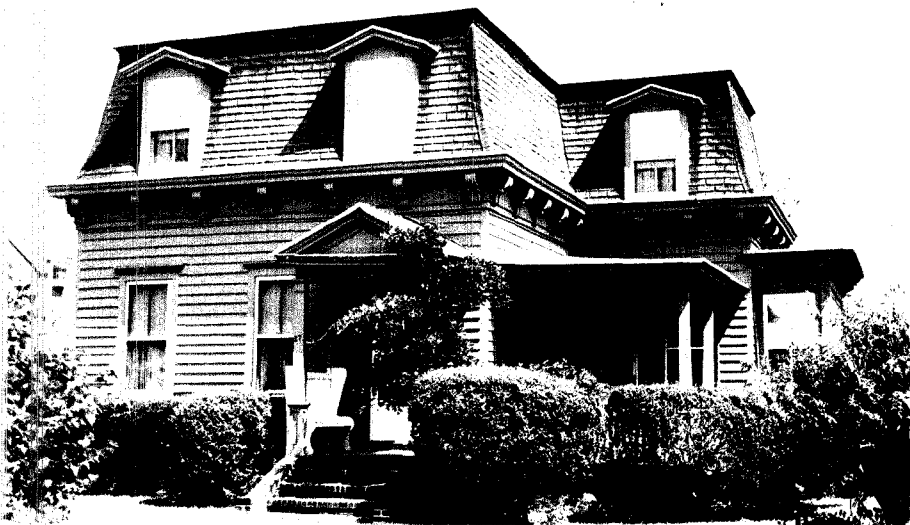
HP-1 Bay Shore Roll #Q5: Neg #2  
Front (west) facade

New roof & Chimney.

This one and one-half story house has a mansard roof. The eaves have large decorative brackets. There is a one bay entrance porch - pedimented and with square posts. The original windows have simple architraves with slightly projecting heads. The dormer windows are gabled. The south side has a projecting wing with a bracketed square bay window.

This house is one of the few Mansard-roofed structures in the area. It retains much of its original detail, i.e., brackets and projecting window heads. It has a one-bay pedimented entrance porch, and a small porch on the south side in front of the projecting wing.

The offset wing also has a mansard roof, brackets, and dormer. On the south side of the wing there is a projecting, bracketed bay window.
