BUILDING-STRUCTURE INVENTORY FORM

* * * * * * * * * * * * * * * * * * * *
<u>IDENTIFICATION</u>
1. BUILDING NAME(S): Formerly A. Dominy House in 1915.
2 COUNTY: SUITOIK TOWN/CITY: ISLID VILLAGE BAY Shore

3. STREET LOCATION: #32 Shore Lame (west side, bet. Gibson St. & Maple Ct.)
4. OWNERSHIP: a. public □ b. private ☑
5. PRESENT OWNER: ADDRESS:
6. USE: Original: Residence Present: Residence

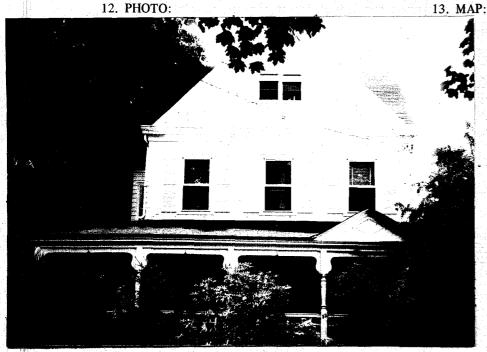
Bay Shore Roll #Q5; Neg. #7 Front (east) Facade

18. OTHER NOTABLE FEATURES OF BUILDING AND SITE (including interior features if known): This Queen Anne style house has its original porch with turned posts, balustrade and stickwork. The porch's pediment has stickwork, as do the lower gables on the north and south sides. On the north side there are flared shingles between the first and second stories. The house has cross gables. SIGNIFICANCE 19. DATE OF INITIAL CONSTRUCTION: unknown
ARCHITECT: unknown
BUILDER: unknown
20 HISTORICAL AND A DOUBTECTURAL IMPORTANCE

20. HISTORICAL AND ARCHITECTURAL IMPORTANCE:
This house has a variety of surface materials, characteristic of the Queen Anne style. There is a combination of pointed and clipped shingle in the main gable. Much of the house has rectangular
shingles, while the first floor is clapboard. The original ornament is retained in the gables and the porch.
The front gables verges have an extended projection above the level of the gable windows. The north and south sides of the house
have gabled projections.
가 있다면 하는 것이 있다. 이 사용을 보고 있는 것이 바로 보는 것이 되었다. 그는 것이 되었다. 그는 것이 되었다. 그는 것이 되었다. 그는 것이 되었다. 그렇게 보고 있는 것이 되었다. 그렇게 하는 것이 되었다. 그는 것이 되었다. 그런 것이 없는 것이 하는 것이 있다면 있는 것이 그렇게 되었다. 그런 것이 없어
