BUILDING-STRUCTURE INVENTORY FORM

YOUR NAME: Town of Islip DATE: 8/1/75

ORGANIZATION (if any): Dept. of Planning, Housing, & Development

- BUILDING NAME(S): #20 ~~Campion Street~~
- COUNTY: Suffolk TOWN/CITY: Islip VILLAGE: Brentwood
- STREET LOCATION: 20 Campion St e.
- OWNERSHIP: a. public b. private
- PRESENT OWNER: _____ ADDRESS: _____
- USE: Original: Residence Present: Residence
- ACCESSIBILITY TO PUBLIC: Exterior visible from public road: Yes No
Interior accessible: Explain Privately Owned

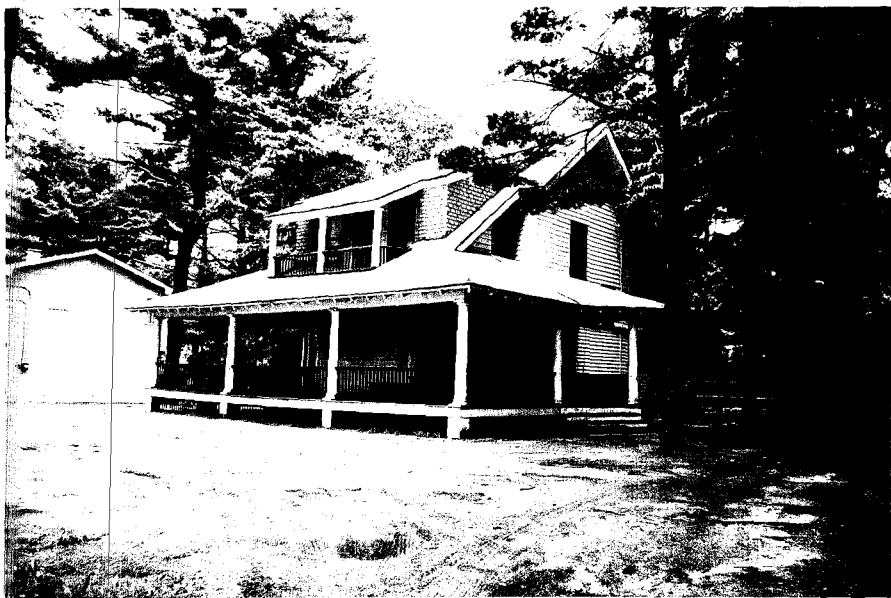
12. PHOTO: Negative No. B-3A

18. OTHER NOTABLE FEATURES OF BUILDING AND SITE (including interior features if known):
Exposed rafters under eaves. Original porch with exposed rafters extending around three quarters of house. Original one over one windows. Flaring out of shingles at second floor level of East facade. Original clapboard.

20. HISTORICAL AND ARCHITECTURAL IMPORTANCE:
#20 Champion Street is an interesting Shingle Style house that has many significant architectural details. Although it has recently been suffering from deterioration it has managed to maintain most of its original details.
